# Engineering Report Expedition 361

Mauritius to Cape-Town SA (30 January to 31 March 2016)

Mike Meiring

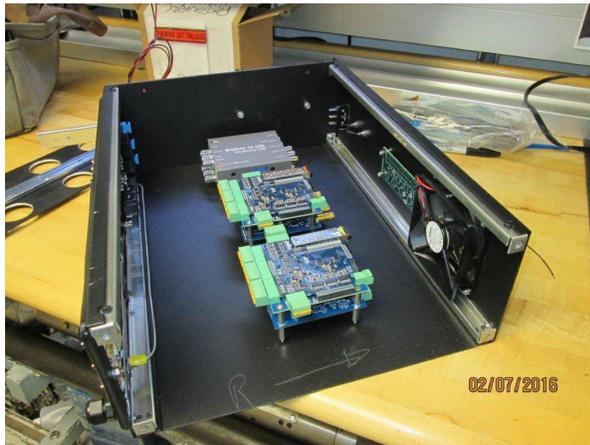
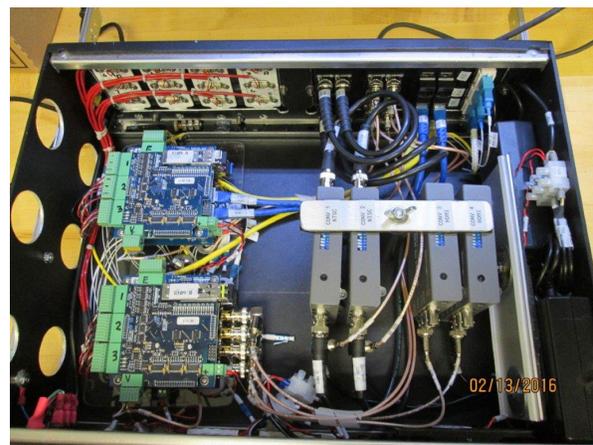
### 1) SURFACE TELEMETRY BOX:

- a) Installed Seaview telemetry cards, Black Magic converters, Optical distribution parts and Power supplies in 4U 19" BOX.
- b) Wired I/O's to backplane connectors.

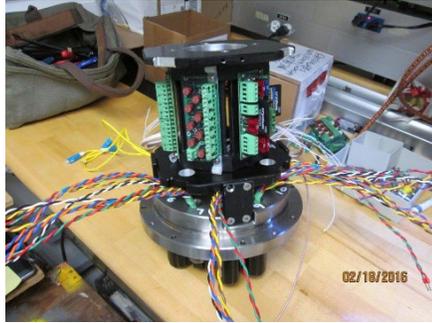
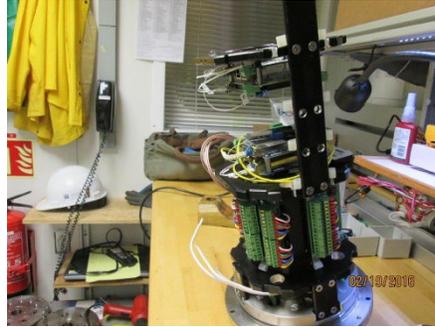
- a) Replaced 7 port end-cap with 11 port endcap.  
Mounting holes for center optical connector were changed from 10-32 to ¼-20. Discovered ¼-20 bolts could not pass through the flange holes in the connector. Siem mechanic drilled/tapped 10-32 holes at 45deg offset. The 2<sup>nd</sup> endcap needs to be modified in same way during CT tie-up. Wired end-cap connectors to distribution boards

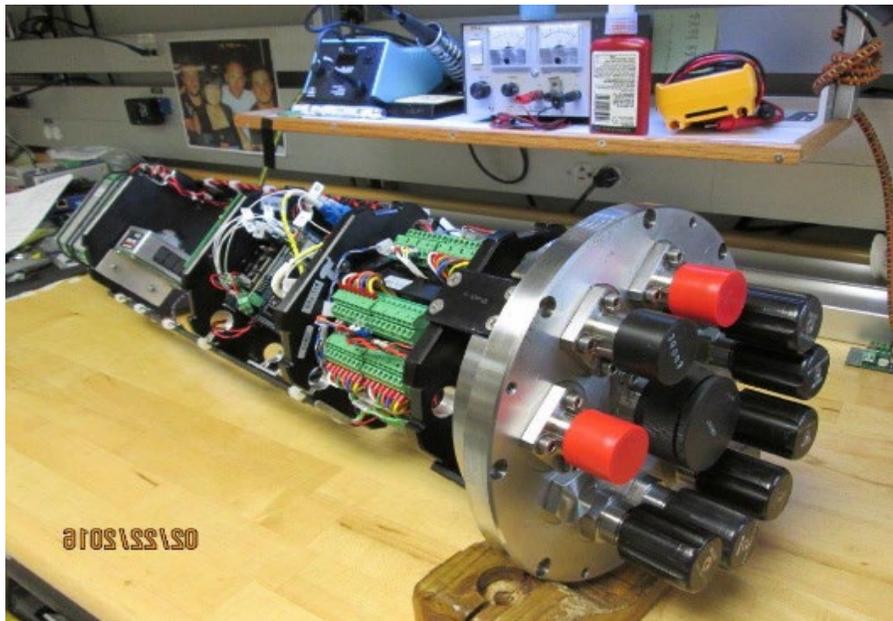
- b) Removed redundant telemetry parts from Pod S/N 1 and installed Seaview telemetry cards. Connected to p-supplies and wired card I/O's to output ports.

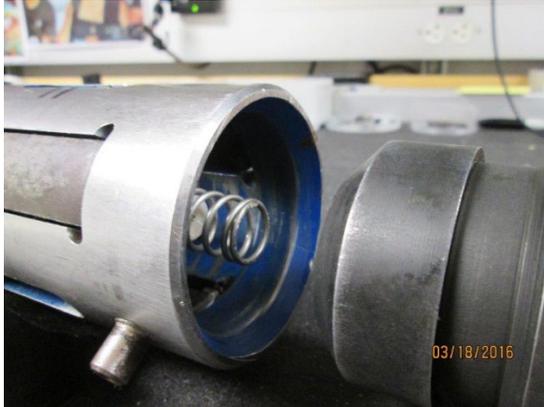
The Hall-effect proximity switch indicating the presence of a tool in the RS latch failed during the Exp 359 test. The initial assumption was that the failure was due to hydrostatic pressure on the Hall-effect semiconductor device but has to be verified. Some development is required to rectify this failure. It was decided to have a work-around ready for deployment on Exp 362./366 An IE4M plug was modified and used in place of the Hall-effect sensor plug. When a pulling neck enters the latch, it pushes against the spring/plug

breaking a contact. Leaving the latch will relax the spring and reset the contact. Status of this contact indicates the presence or not of a fishing neck in the RS-latch.

RS-latch with plug, pulling neck

Two changes have to be made to existing system to accommodate this work-around:

- 1) In the Electronics module) two wires have to be swapped on the MHDG-FCR 7pin connector. (Changes in wiring shown on ERS Schematic diagram)
- 2) In the "Pulling neck", the magnetic bolt must be replaced with standard bolt and adjusted for hole depth of 1.6"

One pulling neck has been modified. Electronics modules will be modified before end of expedition, time, sea-state permits.

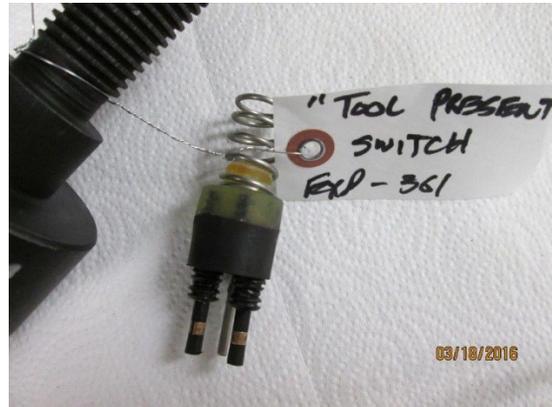
"Tool Present" plug

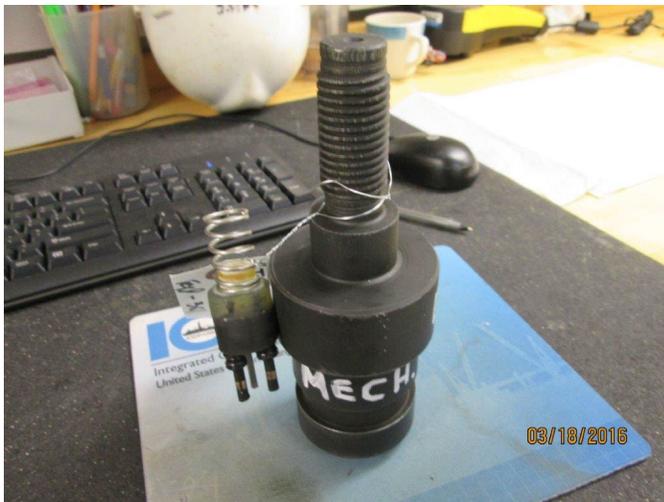
Plug and pulling neck
