## ENGINEERING EXP 371 July-Sept 2017. Townsville-Hobart

### ENGINEERING

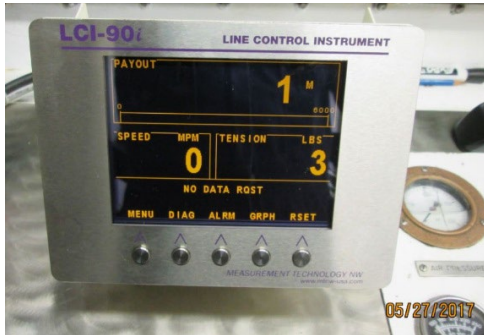
## LCI-90I VIT WINCH DEPTH/SPEED METER:

- LCI-90i meter operational as Depth/Speed meter with comms to DOWComm.exe for remote display on DVR Overlay and Rigwatch.

- Created technical content and forwarded to CS to produce a User Guide. This integrated measurement solution for VIT Depth/Speed is ready to replace the old Veeder and Tach meters in Subsea.
- Temporary LCI-90i User Guide printed and hardcopy with instrument in Subsea.
- Awaiting spare LCI-90i meter from CS.
