ENGINEERING REPORT EXP 378: South Pacific Paleogene Climate

6 Jan 2020 to 4 Mar 2020

OVERVIEW:

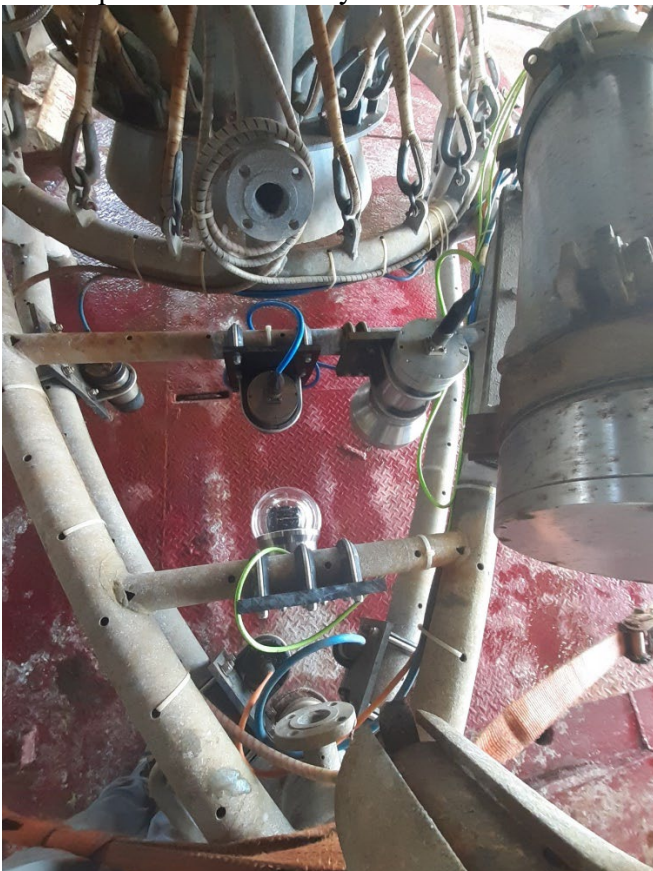
IMENCO OE14-522D PTZ CAMERA:

- Made and installed plastic bracket for the new pan/tilt/zoom camera. The camera is horizontally orientated pointed forward and slightly down. This will limit the ability to look “behind” the VIT but will allow for significantly more intuitive control using the joystick. As the Survey cam can only look forward, it was mounted aft in the place previously occupied by the Reentry cam. The search camera has been moved sideways to the old survey camera position. The re-entry camera was moved forward to the where the Search cam was. The old survey HD-camera has been removed from the VIT and is now a spare for the re-entry camera.

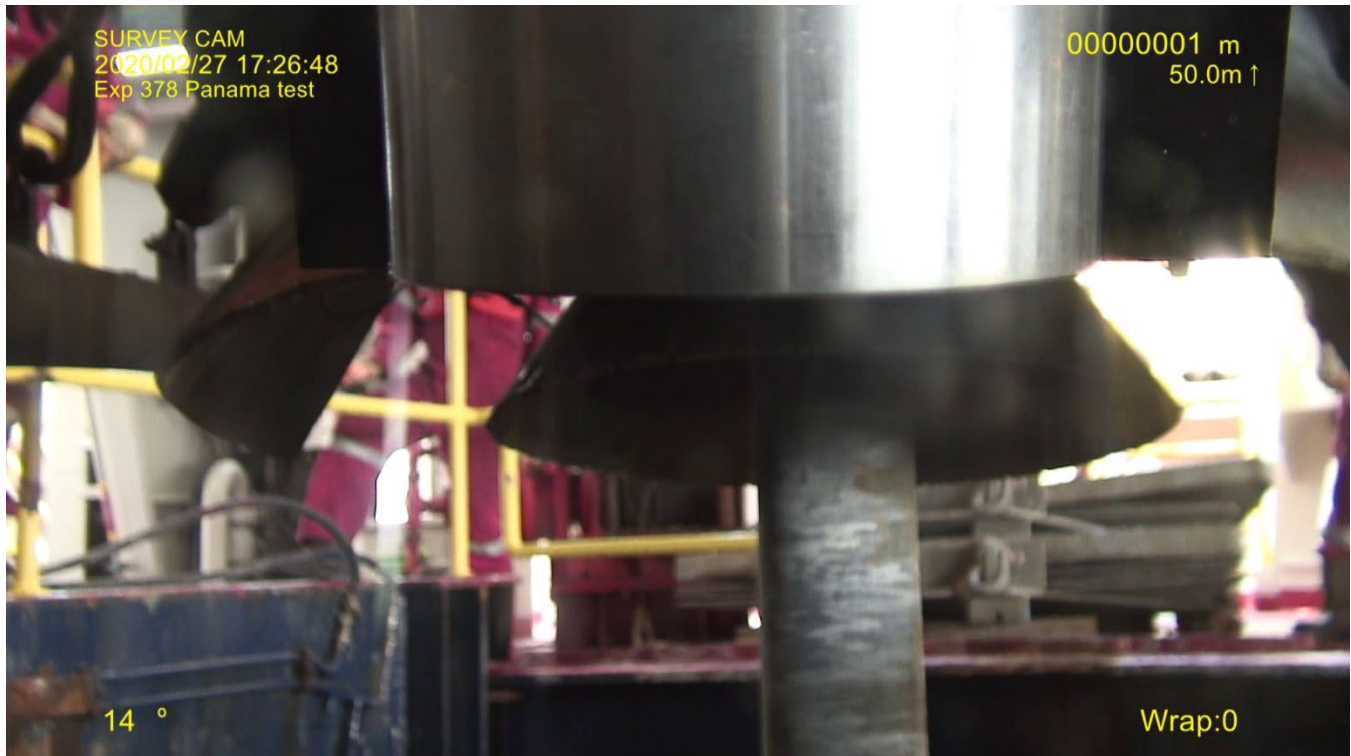
VIT TEST DEPLOYMENT:

After arriving at anchorage in Panama, we conducted a test deployment of the VIT to verify the proper operation of all the cameras and their placements and orientation. All cameras worked as expected and despite low visibility of about 1 meter, the PATZ camera provided some interesting views (see below). The resulting test videos can be found at: P:\2-Engineering Files\1 VIT\VIT PHOTOS and VIDEO\VIT Videos\Exp 378 PATZ camera test

After the test deployment, the tool pusher requested we put the re-entry camera back to its original, aft-most position. Placement of cameras and lighting on the VIT frame requires careful consideration, both to satisfy physical/technical constraints but also to maximize the usefulness of the various devices to their different users. At the time of writing the request was not yet quantified.

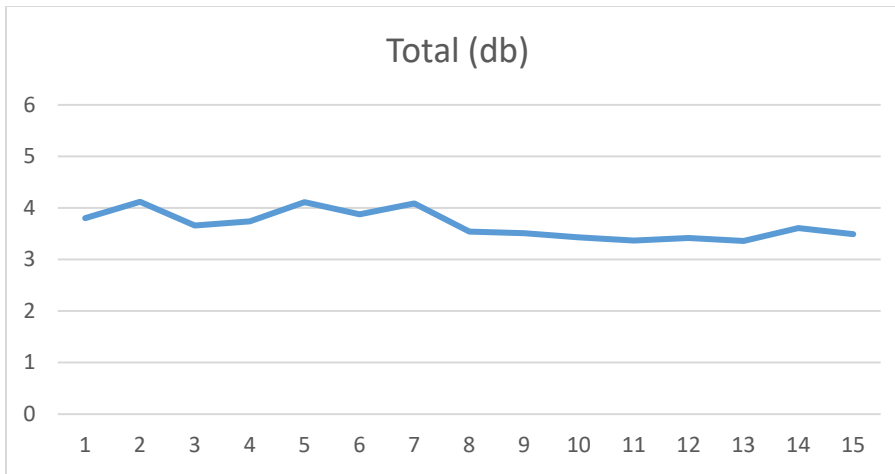
- Flushed devices/connectors with fresh water and sprayed with silicon lubricant.
- Replaced O-rings on re-entry and survey cameras. Cleaned and sprayed pressure housings with silicon lubricant.
- Optical link integrity:
OTDR measurements are periodically made on the spare Brown Fiber from DP to the VIT Frame J-Box. Compared against measurements from previous Expeditions, this could be an early indication of potential issues especially on the FORJ and Umbilical. OTDR measurements on the BRN reference fiber shows no evidence of optical link degradation.
