**ENGINEERING Exp 383 PUNTA ARENAS TO PUNTA ARENAS
20 May 2019 to 20 July 2019**

Mike Meiring

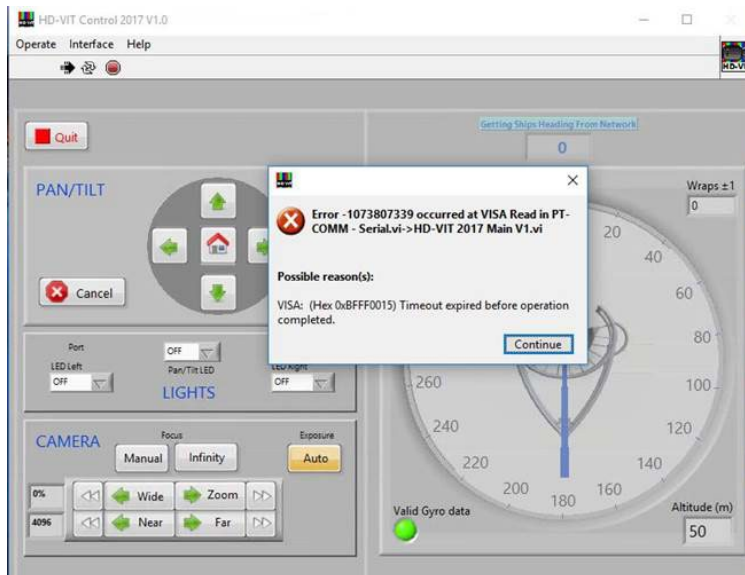
After installing P/T device S/N 3524 it returned the error message below, following a command. It was recently returned from SIDUS following repair.

- The P/T unit shares RS 485 control with LED3. With LED 3 plugged into P/T cable, operation of LED is normal proofing the circuit.
- An older version of the HD-VIT software were launched with the same result, proofing the software.
- Pan/Tilt will become obsolete with new PTZ Survey cam.
- P/T S/N 3524 will be returned to CS end expedition 383.

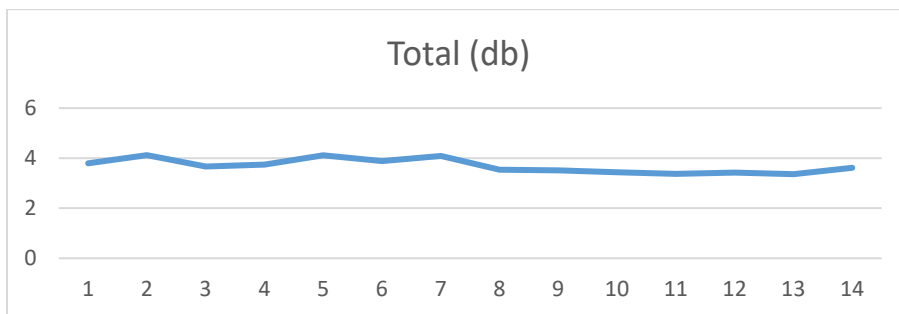
- Flushed devices/connectors with fresh water and sprayed with silicon lubricant.
- Exercised Optical splicing instruments.
- Allowed updates on VIT and SUBCDVR PC's
- All schematics updated.
- Optical link integrity:
 OTDR measurements are periodically made on the spare Brown Fiber from DP to the VIT Frame J-Box. Compared against measurements from previous Expeditions, this could be an early indication of potential issues especially on the FORJ and Umbilical. OTDR measurements on the BRN reference fiber shows no evidence of optical link degradation.

EXPEDITION	SUBSEA J-BOX (db)	FORJ (db)	Total (db)	Length (m)
Exp 362T	1.26	1.3	3.8	7513
Exp 362T 700m	1.6	1.54	4.12	7513
Exp 366 Start	1.12	1.02	3.66	7512
Exp 366 3670m	1.16	1.1	3.74	7511
Exp 366 End	1.59	1.48	4.11	7511
Exp 368 Start	1.35	1.17	3.88	7512
Exp 368 2780m	1.52	1.42	4.09	7511
Exp 371 Start	0.35	0.95	3.54	7512
Exp 372 End	0.94	0.85	3.51	7511
Exp 375 Start	0.34	0.94	3.43	7510
Subic Dry dock	0.9	0.79	3.37	7467
Exp 368X	0.31	0.9	3.42	7467
Exp 379	0.31	0.94	3.36	7466
Exp 383	1.05	1.05	3.61	7466

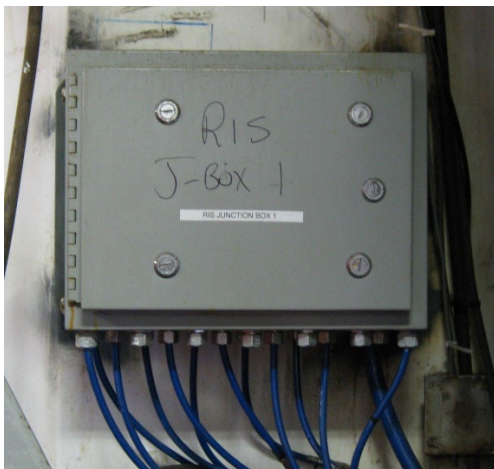
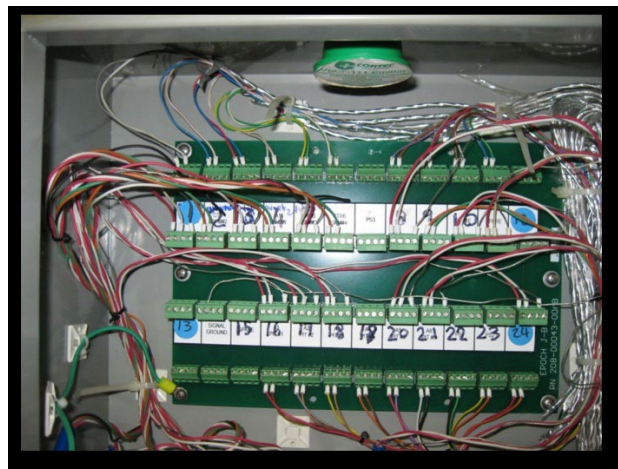
- RIS J-Box1 is badly corroded and needs replacement. Multiple sensors on the Rig is routed through this box to the RIS System in SUBSEA. I suggest a project be created to do this task during a tie-up.

J-BOX to be S/S and be fitted with 12 compression glands to support cable diam of $\sim 0.33''$ and 1 compression gland for $\sim 0.8''$ cable.
