Mike Meiring

#### OVERVIEW:

- Changed out old VIT frame with new.
- Modified Antares loggers for high Temp range.
- Deployed Kuster WST.
- Deployed the ETBS Temperature tool.
- Deployed VIT system.
- Researched potential gyros for COT project.

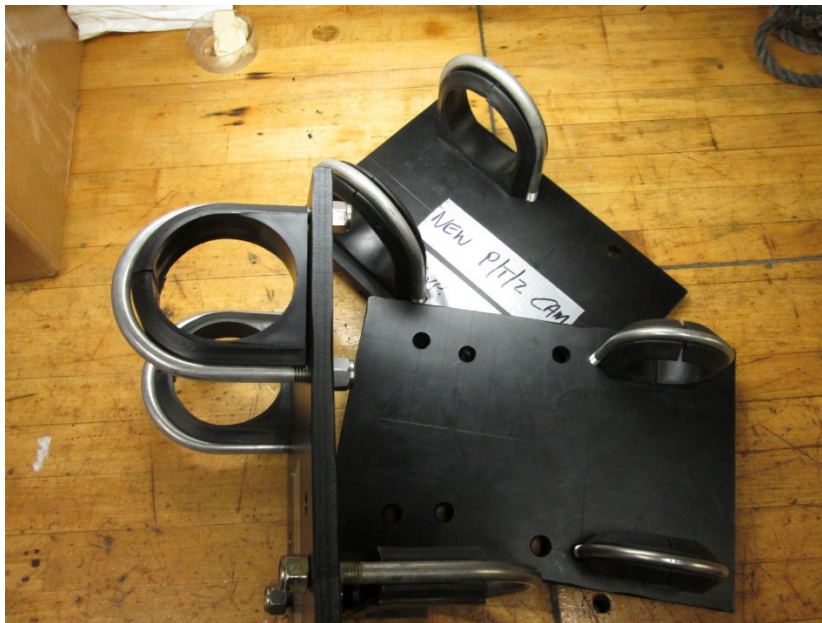
- All steel brackets on frame were replaced with plastic.

Plastic brackets

- Dimensions for most brackets are 8" X 12". A standard 12" X 24" sheet will make 3 x brackets. 0.5" for normal and 0.75" for heavier devices. Mounting the devices to brackets and the brackets to the frame are done with Vibration isolating U-bolts. Mounting to the frame are on either a 2" or 3" pipe support.
- McM # for UHMW polyethylene sheeting:

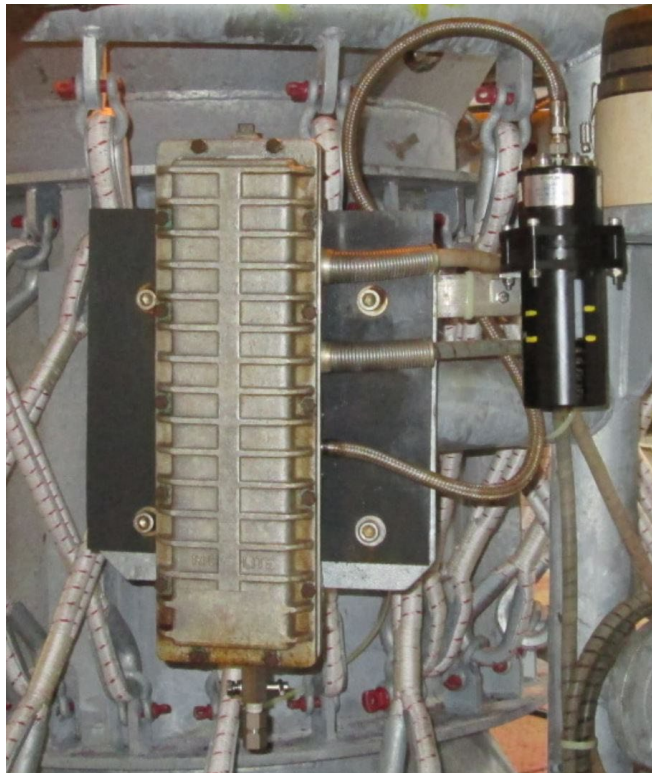
- Installed new Forum 270cc compensator #SA-HC-0406-MAS on the Frame J-Box.
- New silicon oil fill procedure updated in VIT AUG.

Frame J-Box with new Compensator

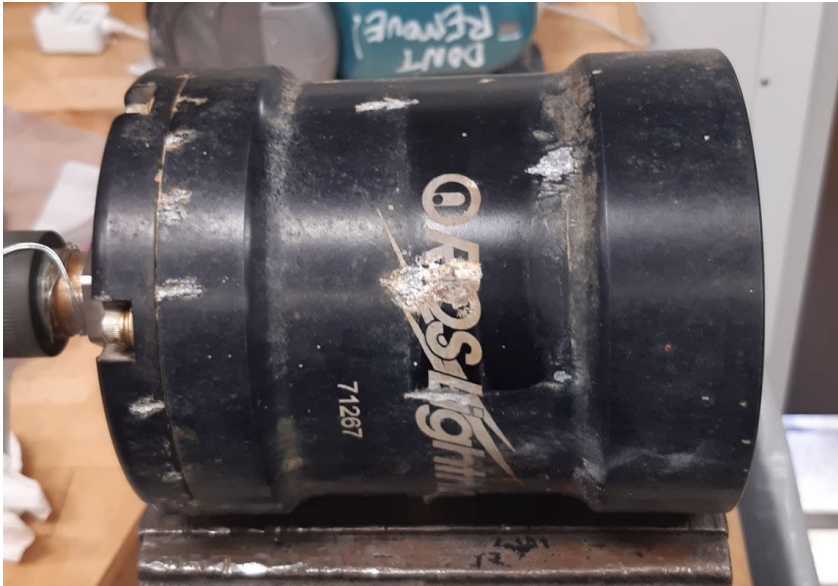
- Significant pitting is taking place due to compromised anodizing on the aluminum housings of the ROS LED lights. Plan to replace these lights in near future. We currently have three on the frame and one spare. They each deliver 10000 lumens at 90deg flood. Replace with similar flood lights.

Pitting on ROS LED Light

- No spare VIT Main hybrid connector/ pigtail.
- Order new Survey PTZ camera on.
- Start planning to replace the ROS LED lights.
- SUBCDVR Windows10 change.
- SUBCDVR CPU 100% issue.
- HD-VIT code changes.
- ETBS/KUSTER deployment procedures and hardware.
- VIT Hand-over to Siem
- RIS system replacement

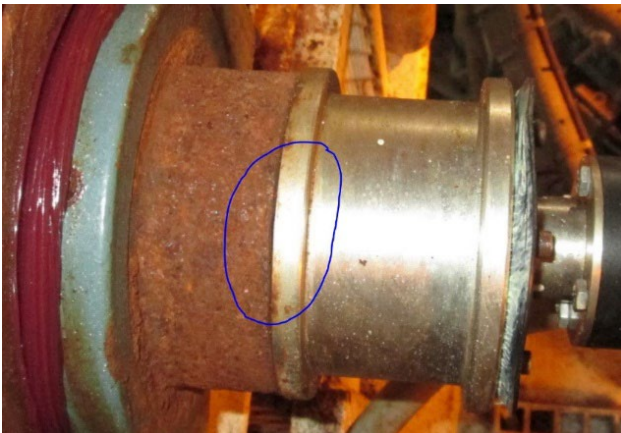
Before

Another potential cause for failure could be water ingress into slipping. Water can be trapped in the drum shaft where FORJ is housed when drainage becomes compromised. The drainage gap between the FORJ flange and Drum shaft face was increased to  $\sim 1/16''$  See images below.

Checking free space around FORJ in shaft and drainage should become a maintenance item.

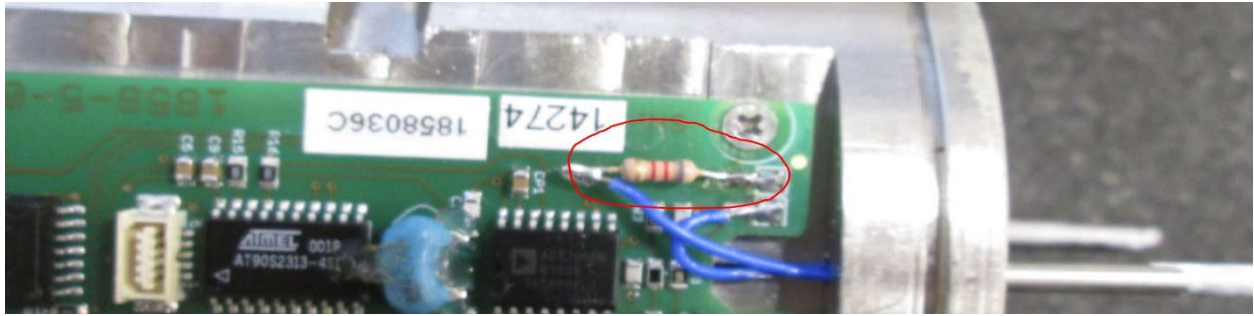
- Science party expected tools onboard to measure temperatures between 60C and 80C
- APCT3 S/N 36 and SET2 S/N 39 were modified to extend their measuring range. A 8200 ohm resistor was added in series with the thermistor.

Both tools were calibrated in a crude temp bath against a glass thermometer reference. Curve fitting was attempted and The APCT3 Temperature cal file was changed to:

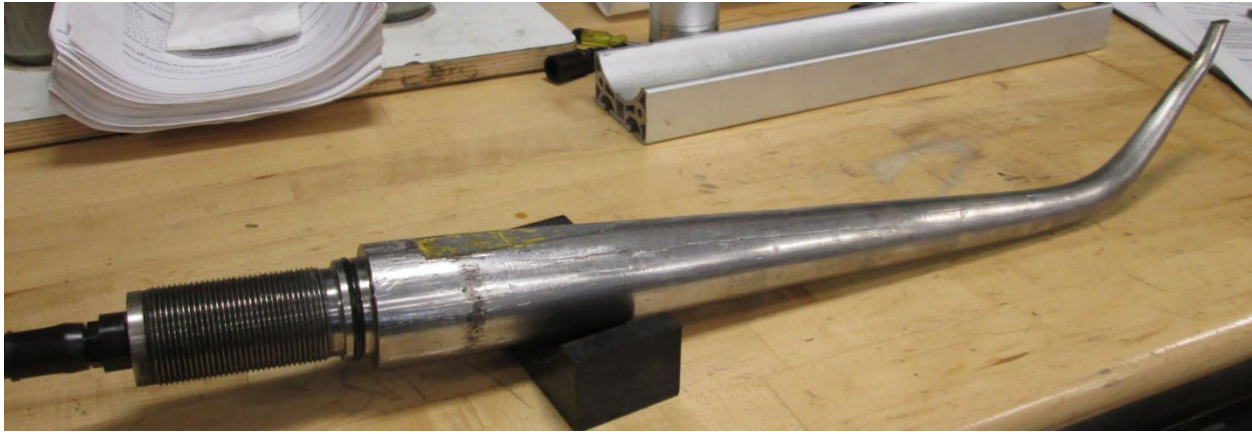
- SET2 S/N 39 was damaged in hole U1548C. The colet protection in the CDS did not operate. Electronics was not damaged. The High temp modified S/N 39 Electronics were then transferred into SET2 S/N 49 housing for remainder of the expedition, Damaged tip was discarded of.

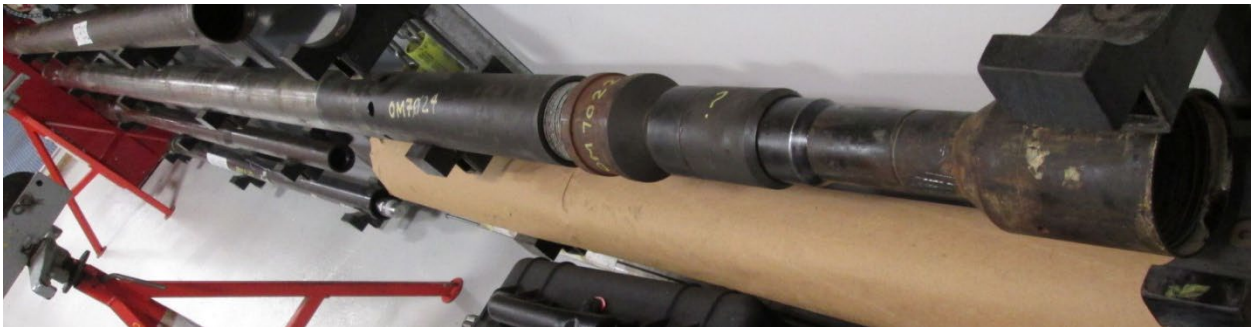
- Deployed this once with no tool issues.
- Review hardware for interfacing tool to the drilling system and deployment procedure. CT devised a plan to make this work.

Improvised deployment hardware

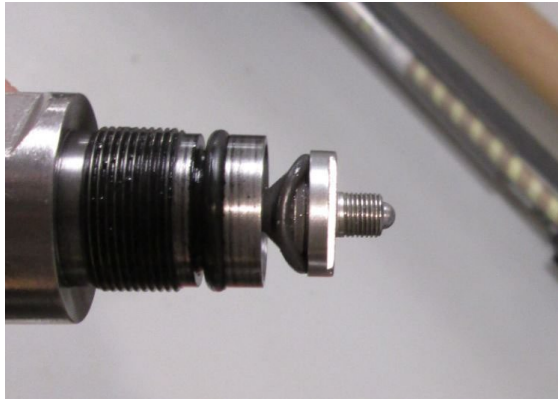
Fig 1

- Tool operated as designed, returning water samples under pressure.
- O-Ring issue:  
When the Transfer Head Assembly Handle was screwed into the Valve Body Assembly to release the water sample, the pressure would blow the valve o-ring out of its groove (Fig 1), with adequate pressure it was destroyed. (Fig 2).

The chamber pressure is released by compromising the o-ring seal. Damage to o-ring depended on sample chamber pressure. O-ring was destroyed 3 out of four deployments. Pressure >2000psi. This did not affect the sample taking negatively, as the o-ring blew out when sample chamber was in process of being de-pressurized and o-ring had to be replaced anyway following a deployment.

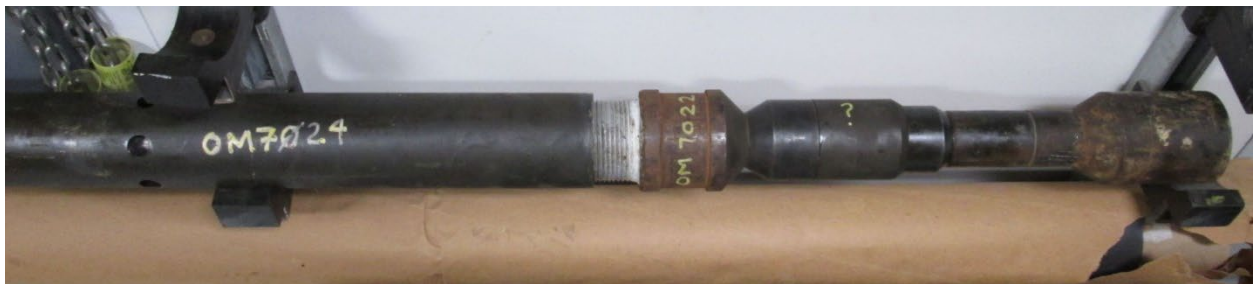
- Review hardware for interfacing tool to the drilling system and deployment procedure. The tool was deployed with the same hardware devised by CT to deploy the ETBS. However, in this configuration the holes in OM7024, were inside the drill pipe, making it unlikely for any flow through the tool while stationary in the pipe in a flowing hole.

Improvised deployment hardware
