**Expedition 385T**  
**Panama Basin Crustal Architecture and Deep Biosphere**  
**Antofagasta to San Diego**  
**18 August 2019 to 16 September 2019**

**Expedition Engineering Report**  
**J. Van Hyfte, B. Rhinehart, TAMU Engineers**

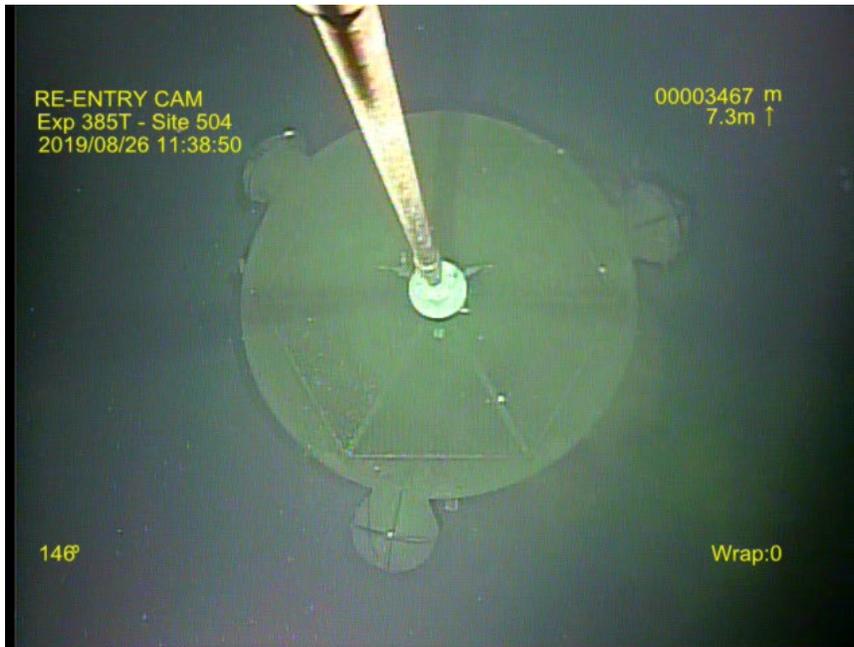
Figure 14 Overshot on 504B

After tripping, lowering the camera, and positioning the vessel over 504B, three attempts were made to latch onto the platform. The assembly was stabbed over the center pipe using the guide funnel and then set all the way down onto the superstructure, each time with progressively more weight (Fig 13). And each time the overshot failed to “grab” the 6” center pipe. The drill pipe was tripped out of the hole and the overshot assembly removed.

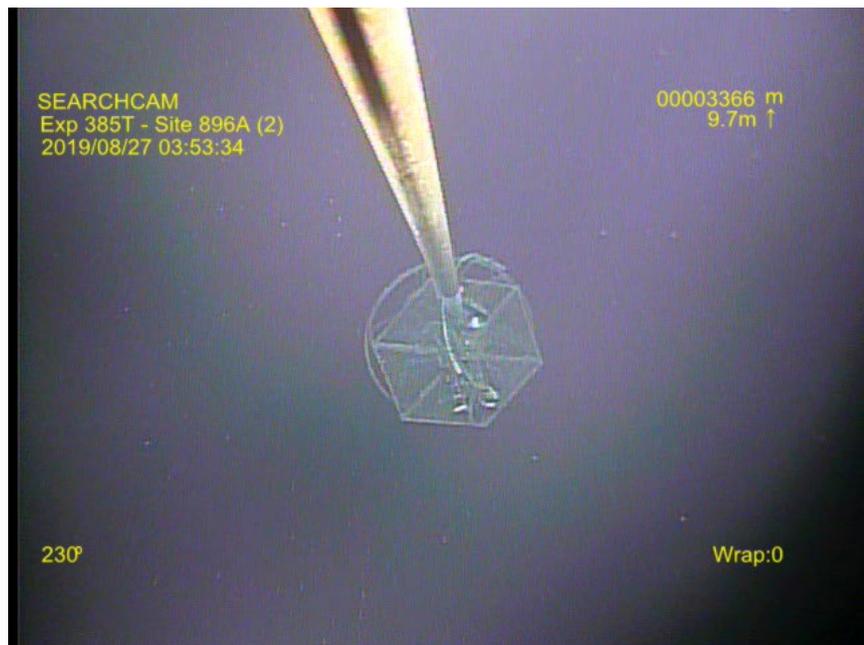
Figure 13 896A Platform on the Hook

With the pipe over 896A and the camera down, the ship was maneuvered over the platform several times. The hook was run just along the top of the expanded metal that made up the floor of the platform, with the intent to hook the underside of the superstructure. Instead, a well-timed downward heave pushed the hook through the expanded metal, catching on the substructure support. The pipe was pulled up, with the platform, for 10 stands (more than the length of the overall installation – see Figure 14).

The pipe was again lowered as the ship offset, first away from the hole and then back toward the hole, trying to see if the upper packer and the lower lead-in package had been retrieved with the platform. Their presence could not be confirmed. Next, the pipe was worked up and down, trying to release the platform. The pipe was lowered further to work the platform up and down off the sea floor, and yet the platform hung on. The pipe was pulled to surface with the platform.

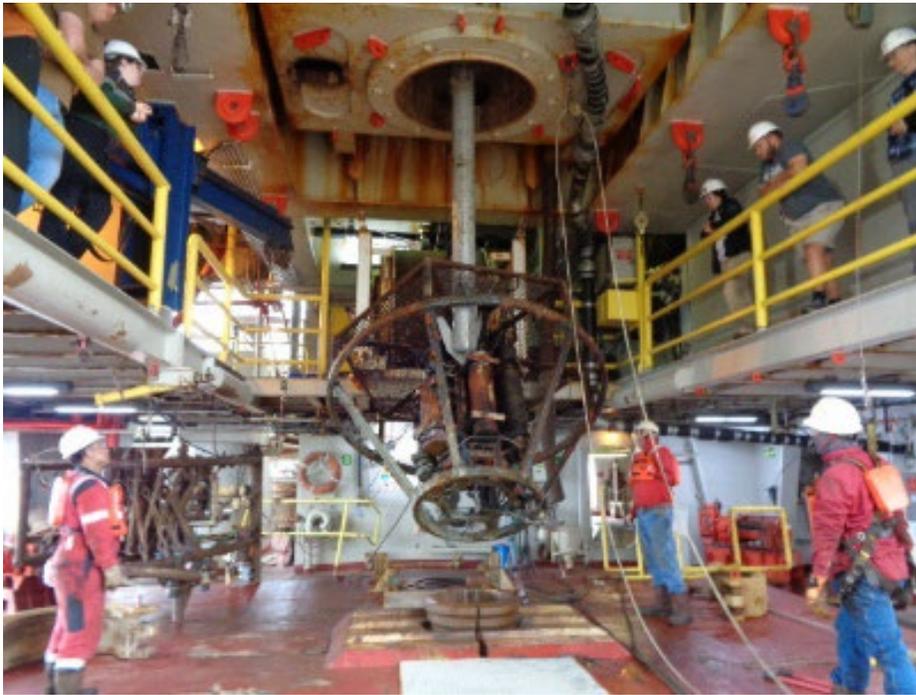
Figure 16 896A Platform in the Moon Pool

Once in the moon pool (Fig 15), it was confirmed the upper packer and lead-in package were not attached, with the supporting cable parted just a few meters beneath the platform. The platform was flame-cut on one side, allowing it to safely slide off the hook onto the moon pool doors.

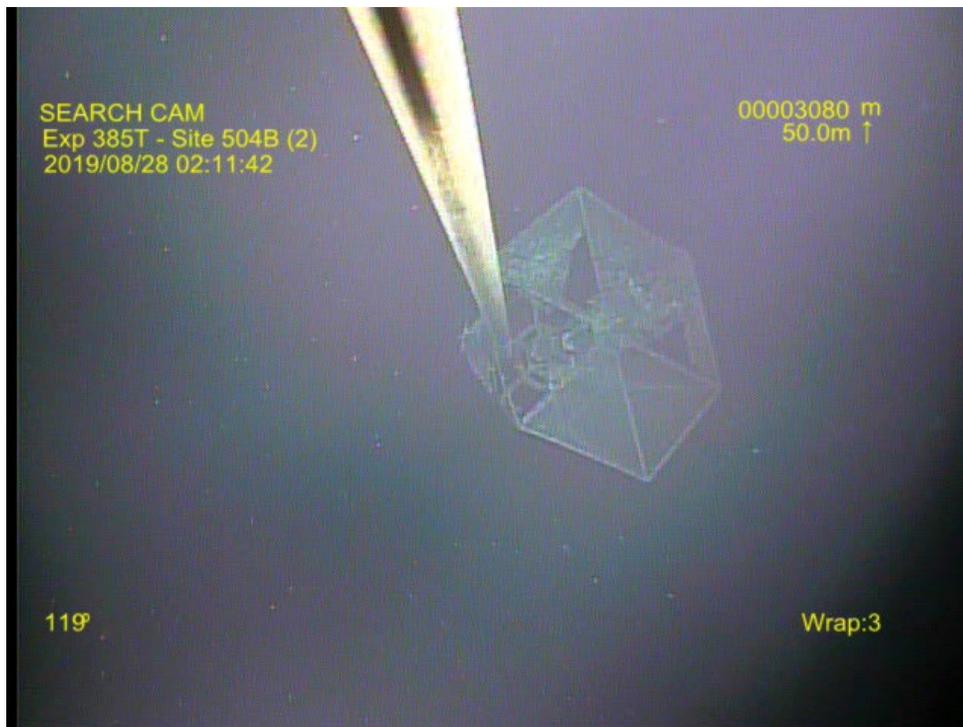
Figure 17 504B Platform on the Hook

The hook BHA assembly was again run down and positioned over Hole 504B. A similar procedure was attempted, running just across the expanded metal floor and trying to hook the superstructure. After several attempts, the hook was stabbed down through the top of the platform. However, this time the pipe offset toward the outer edge of the platform and latched on there (see Fig 17). The pipe and platform were lifted up 12 stands, offset, the camera retrieved, and the pipe tripped up.

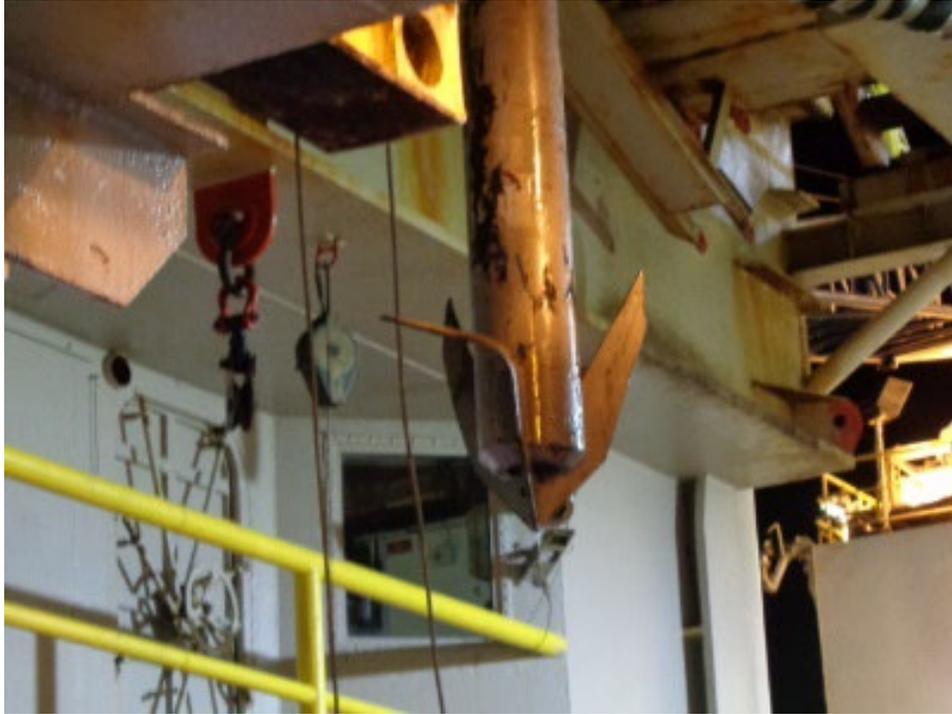
Figure 18 Bent Hook and No 504B Platform

Back at the moon pool it was discovered the 504B platform has slipped off the hook. One of the prongs on the hook was severely bent, possibly against the side of the reentry cone, allowing the platform to slide off (Fig 18).

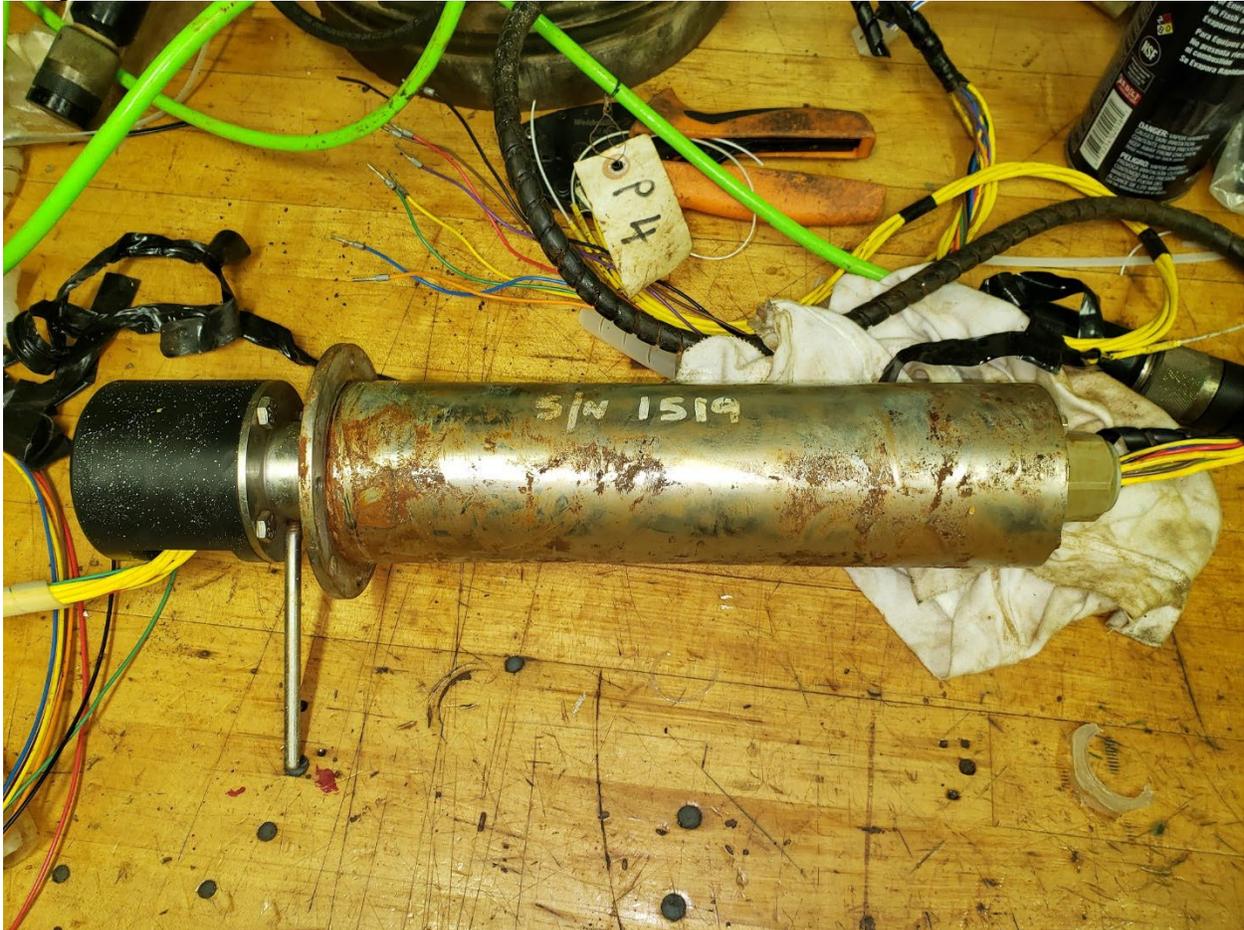
During the fifth (5<sup>th</sup>) reentry operation, all VIT video feeds failed due to VIT system power failure. The nature of the failure was found at the 480VAC 3 $\phi$  main contactor where the contactor fuses were found to be blown, indicating a short in the power sub-system. Siem electrical technicians performed a short troubleshooting exercise while the VIT system was still suspended, to determine the cause of the problem with no joy. The VIT system was then recovered to the moonpool deck, and a more extensive examination of the power system was undertaken to determine the cause of the electrical short.

During the subsequent inspection of the complete VIT main power circuit, a short circuit issue was found in the power contacts within the FORJ (IODP part number OM3027, serial number 1519). The unit was replaced using the IODP spare (serial number 1518), and the power system was put back into service.

Figure 19. Alpha Slip Ring Serial Number 1519 taken out of service and returned for repair.

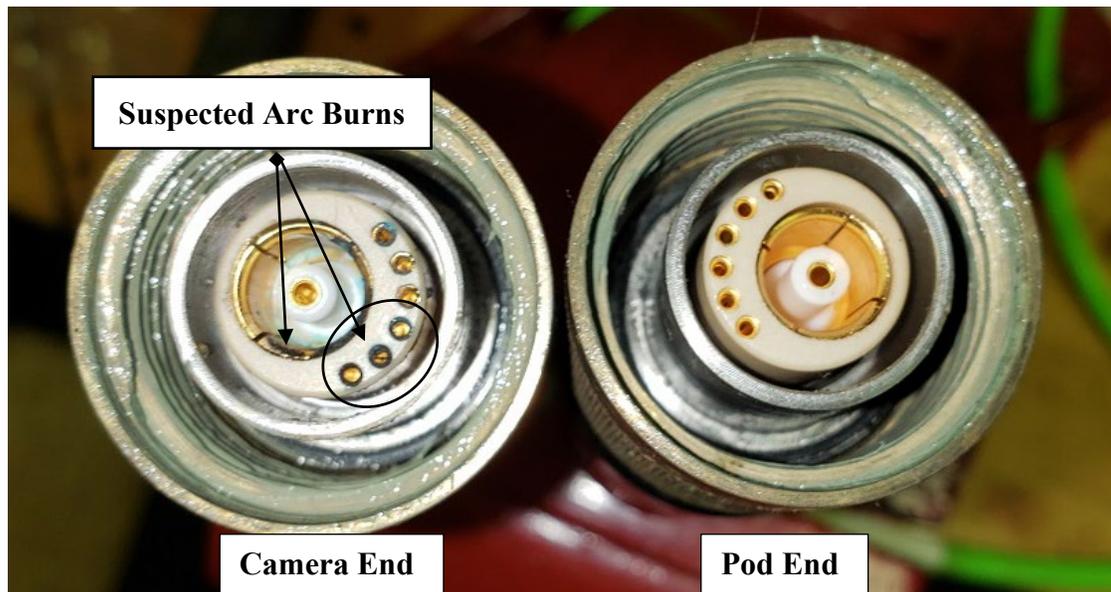
One of the OV0841 HD Video cables on the “Survey” camera was initially suspected to have caused the electrical short, as that camera had experienced a transient video failure in several previous reentry operations, although the failure was short lived (i.e., the feed came back spontaneously on its own) The cable and camera were removed for inspection and it apparent arc-burns were found in the camera end of the cable (See Figure XXX below). It was determined that there are no IODP spares for this part, and as such, the cable was cleaned as best as possible and returned to service.

Figure 20. Suspected Arc Burning on OV0841 Cable

### Action Item: JVH to order one (1) spare OV0841 cable from supplier
