Expedition 390 South Atlantic Transect I

Engineering Report

Cape Town, South Africa to Cape Town, South Africa
09 April 2022 to 09 June 2022

Matthew Allen, Development Engineer

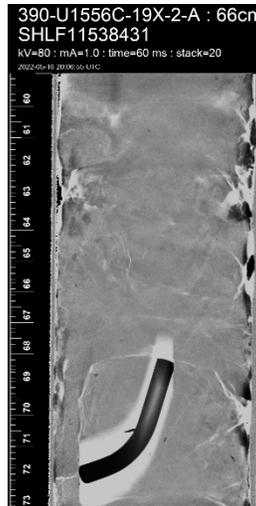
1. Modifications to prevent shear pins pieces falling free. Below is an image of the large piece of an APC shear pin that was returned inside a core.

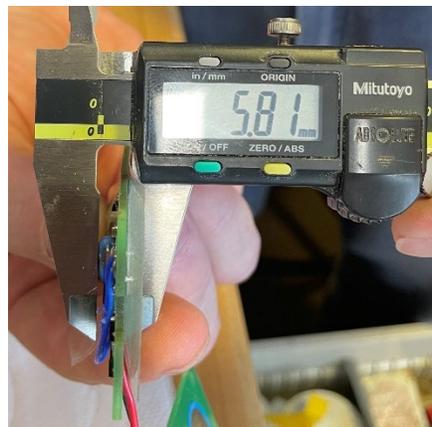
One of the APCT3 metal frames was found to not fit inside the cutting shoe. It was measured and found to be out of round, as well as having some “high spots” due to machining. The spots were ground down, but in the process of test fitting it inside a shoe, the temperature probe was broken off inside a hole in the cutting shoe. After many attempts, I was able to successfully fish the probe out of the hole, saving the cutting shoe.

Additionally, one of the APCT3 boards was shorting out to the cutting shoe. It was measured, inspected, and found to need silicone and insulation. It was repaired and has been working.
