Engineering Report Expedition 396T

Dean Ferrell 12/6/21

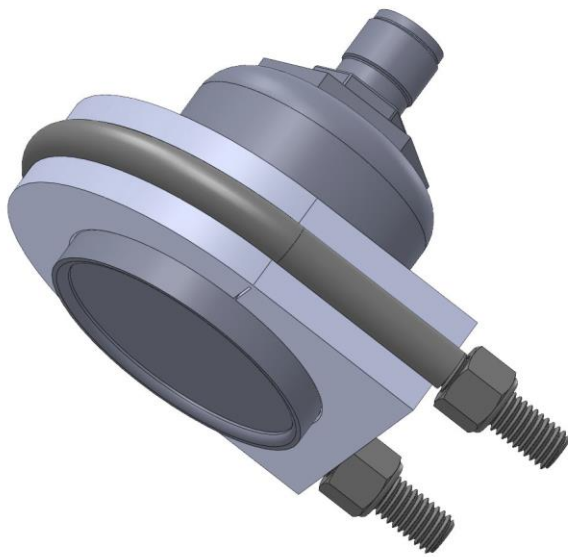
Figure 1 Preferred MLED mount design

The existing ROSYS LED lights are no longer produced and as they fail will need to be replaced by new ROSYS SeaStar LED flood light. Unfortunately, these are not direct replacements, and require different mounting as well as a different communications protocol. Therefore, a new mounting bracket was designed as well as, software modifications made. Unfortunately, we did not have time to purchase new mounting brackets.

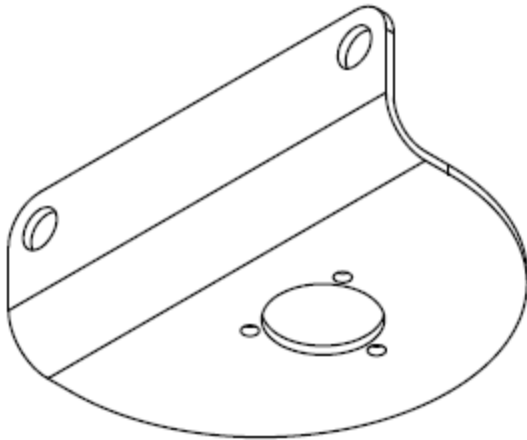
Figure 2:L Bracket Design

A 3-D printed version of the mount was made, but it is not solid and would crush under hydrostatic pressure. In an emergency, we might be able to print a solid version, but we feel the best short-term approach would be to fabricate an L- bracket on board to attach the LEDs to the VIT frame.

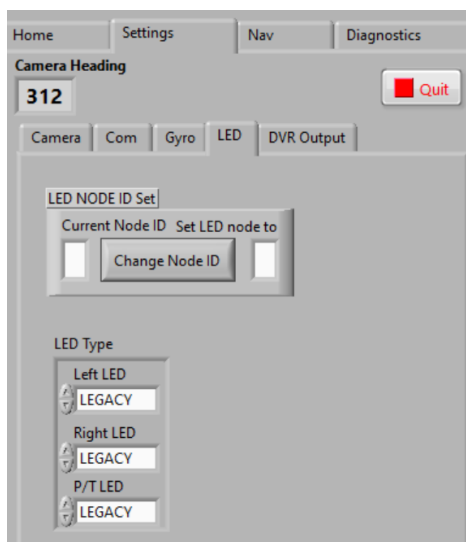
Figure 3VITOF Control Software Settings

To change the control software settings, run the program as normal, then open the advanced interface, using the tool bar menu. Select the settings Tab and then the LED sub-Tab. Here each position can be set to “Legacy” or “SeaStar”. You must close the program using the quit button and then restart the program for the settings to be changed.
