# Expedition 397T (Cape Town, SA → Lisbon, Portugal) Engineering Report

10 September–11 October 2022

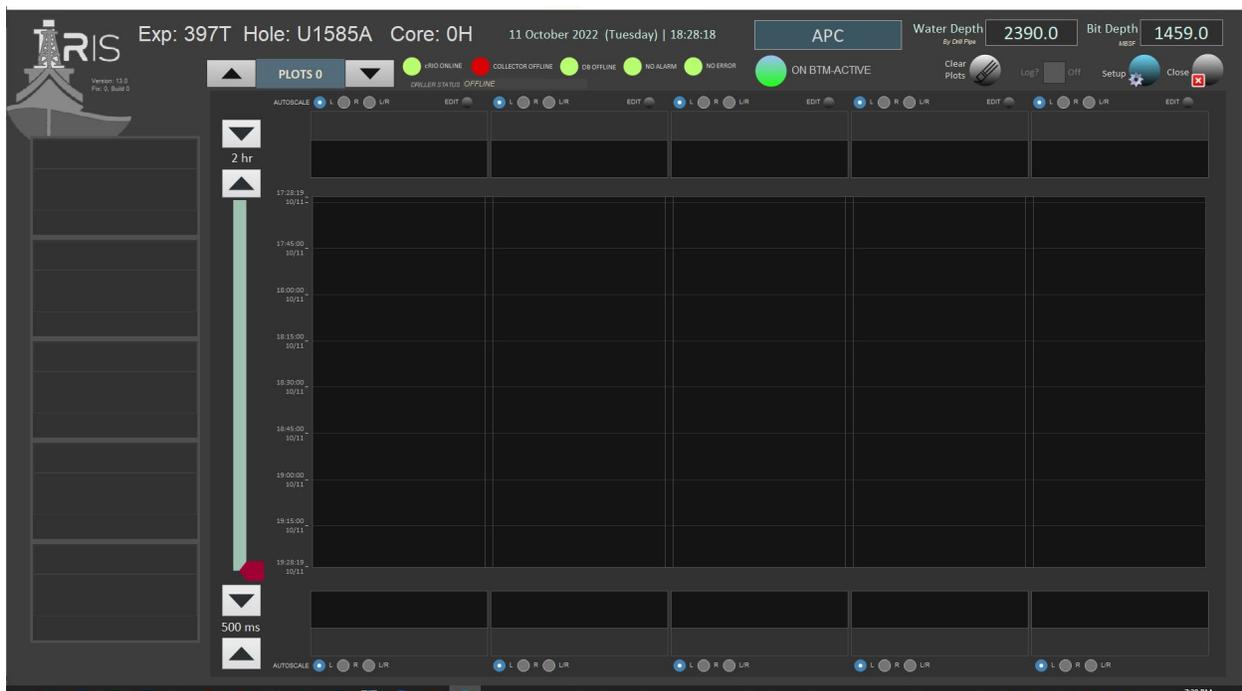
Figure 1. iRIS General User's Interface

Bill Mills has been working on debugging and updating the iRIS GUI. The latest version (Ver 13, Fix 0, Build 0) is deployed and we will encourage staff & scientists to use this on Exps 397/398 and provide feedback. Initial versions were tested during coring and drilling activities on holes U1584 and U1585.

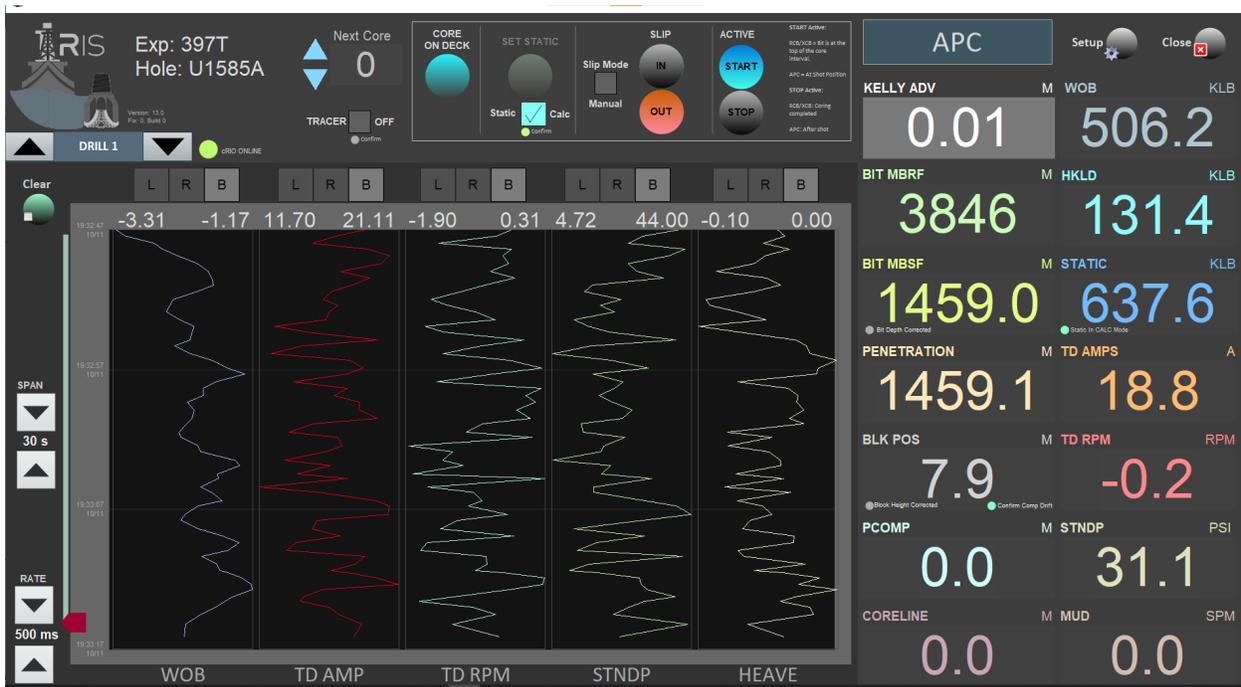
Figure 2. iRIS Driller's Interface

Likewise, the Drillers Interface (Ver 13, Fix 0, Build 0) deployed continued debugging and development. Most likely one more revision to fix a known bug will be fixed and re-deployed. We are going to encourage the Drillers on Exp397 as time allows, as they will be fully engaged with drilling/coring activities. We are hoping to get some feedback from them on 397 and 398 to complete debugging and revisions during the upcoming tie-up after 398.
