Expedition 398P/T

Expedition Engineering Report

J. Van Hyfte, B. Miller, JRSO Engineering Support

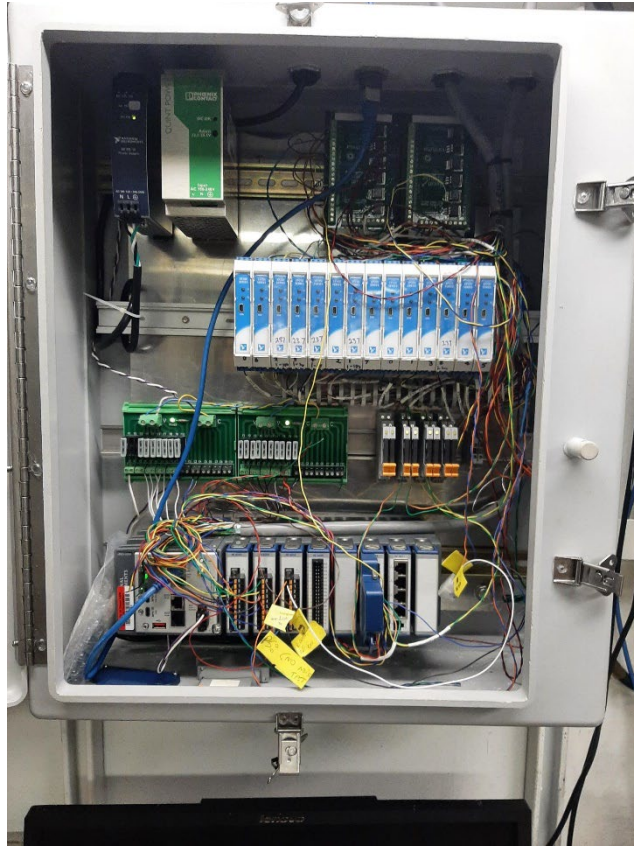
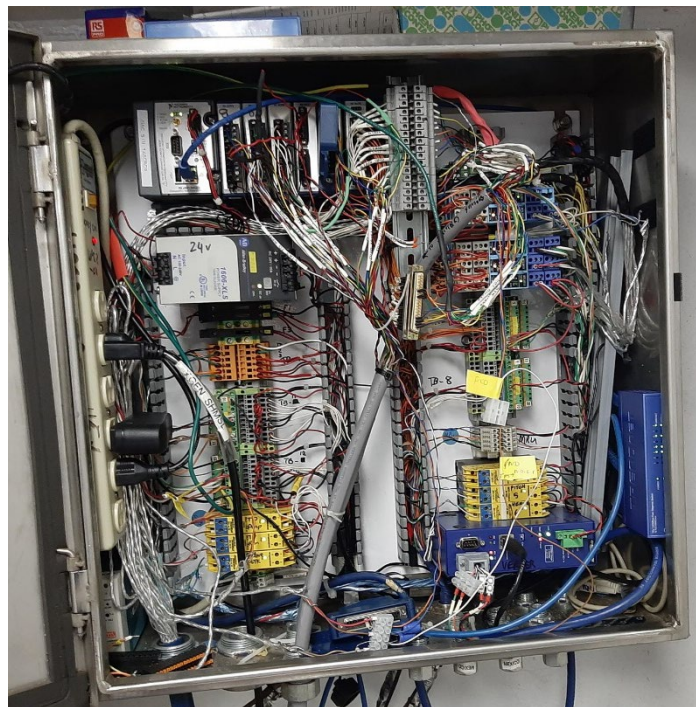
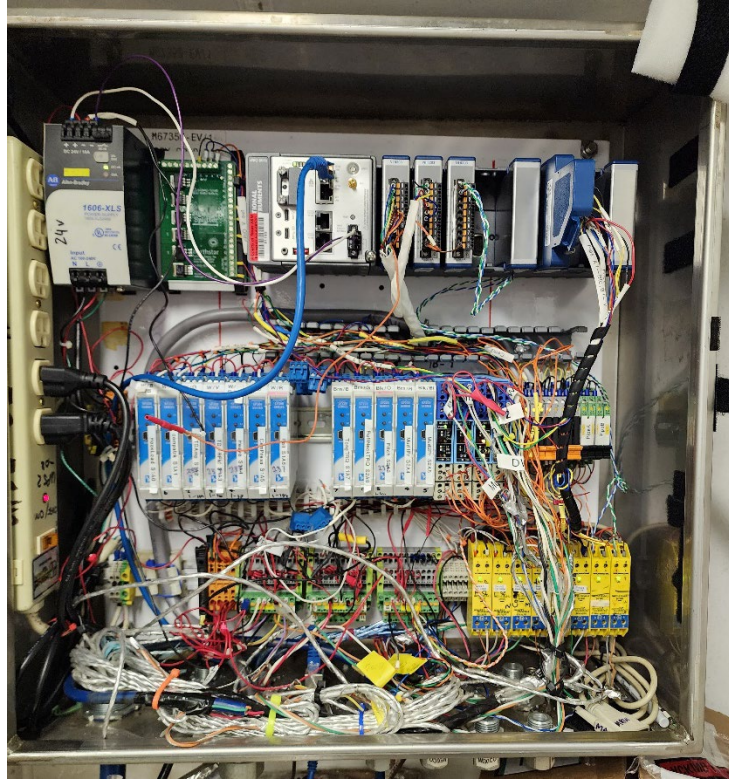
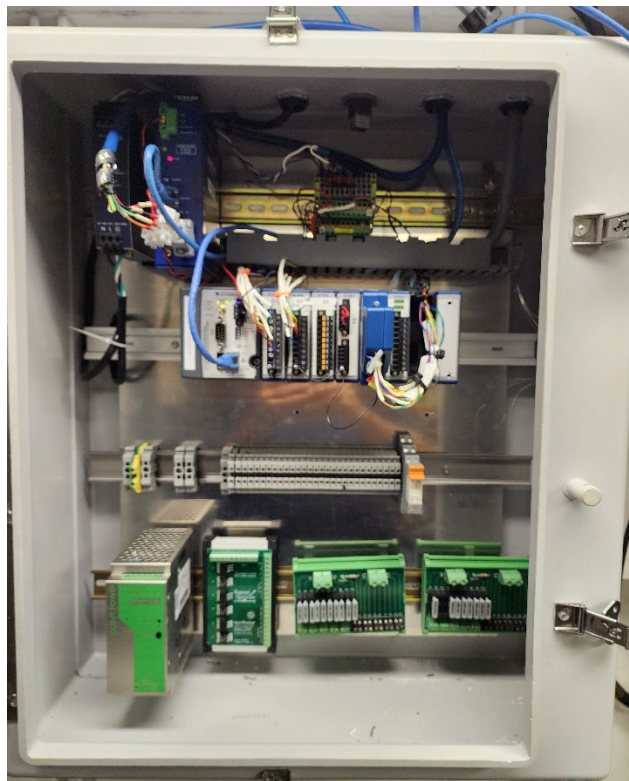
JRSO contracted a former electronics engineer, Dean Ferrell, to prepare the two (2) existing rig instrumentation system (RIS) junction boxes (j-boxes) in the subsea shack for promoting the iRIS j-box FROM secondary TO primary data collection system and demoting the RigWatch j-box FROM primary TO secondary data collection system. In this move, the j-boxes are now ready when the RigWatch rig instrumentation system is completely removed from service, currently scheduled following JRSO expedition 395 in Fall 2023. At that point, iRIS will be fully implemented, tested, deployed, and integrated into the JRSO's Laboratory Information Management System (LIMS) used to collect all coring, drilling, and lab processing data for all recovered core samples.

While the scope of this project was to not only relocate major components of each RIS system to prepare for the eventual decommissioning of the RigWatch RIS, the scope also included a general

cleanup of the wiring components to improve the general organization of the iRIS j-box. However, due to a logistics issue at the start of the expedition, the wiring components were not available until late in the port call portion of the expedition. Because of this, the work will be scheduled at a later tie up period, tentatively scheduled for Expedition 400T (Oct-Dec 2023, Amsterdam)

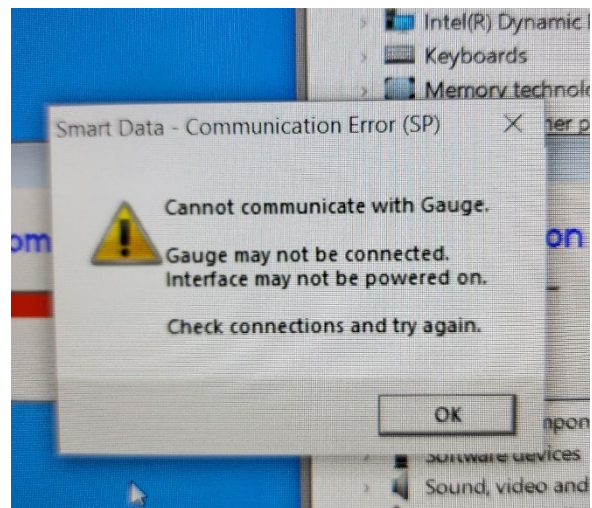
Figure 11. SmartData Comm Error

The Extended Temperature Borehole Sensor (ETBS) was readied for use on Expedition 399 during this leg. However, it was determined that the software used to communicate with the datalogger (SmartData® by MicroSmart Systems) loaded on the desktop computer used in the DownHole Measurements Lab (DHML) was unable to communicate with the datalogger unit.

The first step to alleviate this problem was to download and install the latest version of SmartData® (version 23.3.6) from the supplier. This was not successful, and we began communications with the supplier to determine the cause of the errors. New software, including new drivers were downloaded and began the install process again. Once again, this was unsuccessful.

Working with the JR MCS staff, a fresh laptop was provisioned, and the step-by-step guide supplied by MicroSmart was run. The original driver errors were not observed,

The corrected drivers had to be installed using admin privileges and suppressing the Windows “installation of unsigned drivers” security settings to allow the COM ports to be installed and assigned. With these now installed, communications were restored, and the tool was able to communicate.

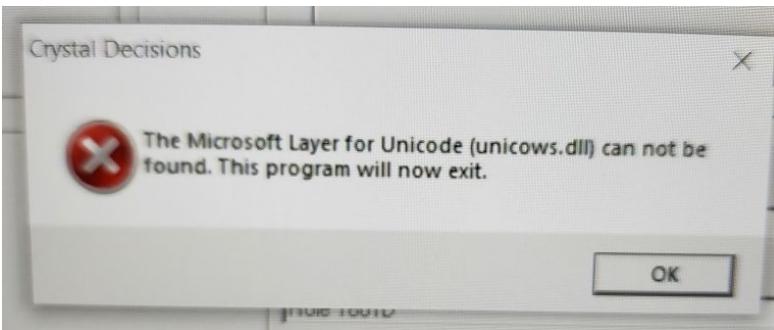
Figure 14. Fatal DLL Error

Next a series of DLL errors were found, one of which caused a fatal error in the SmartData program.

The cause of which was found to be another set of DLL's that needed to be installed with elevated privileges. The last error is not a fatal error, and has not found to cause any errors, but simply a notice that can be cleared.

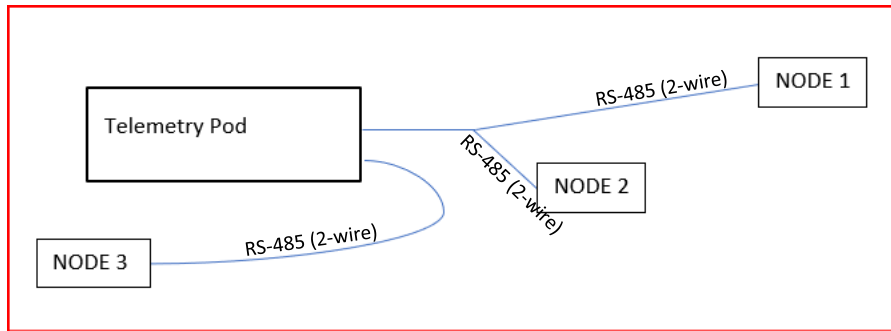
Figure 18. VIT in situ Cabling Diagram

- There is a communication issue with right and left lights that share the same comm lines. It appears that both lights try to transmit at the same time resulting in framing errors. As a result, only one light can communicate with IRIS and is capable of intensity adjustments.

- The center light does have a 10 to 12ms response time issue.
- The center light will also default back to it's factory default settings; comm address 1, powerup intensity of 0%, and max intensity of 100%.
- These problems don't seem to be attributed to the light for the following reasons:
 - A new light was installed at the center location and had the same 10-12ms response time.
 - The new light lost its preprogramed settings and reverted back to the factory default settings.

- The left light responds to commands from IRIS within 500ms yet goes through the same distance and equipment as the center light.
 - All indications suggest that the problem resides in the subsea pod, which at this time can't be opened for inspection.
- f) Common to All Lights
- On power up, all three lights power up to the “powerup intensity level” which was preprogrammed to 60%.
 - If all the lights stop communicating with IRIS, cycling the power off and on will bring all the lights back up the powerup intensity level of 60% (unless the memory is lost)
 - Communication response time from light on VIT to the DP computer was between 152ms to 167ms
 - Communication response time from light to computer on the bench was between 70ms to 80ms

1. Change center light address to 1 in IRIS software to align with the factory default address when/if the center light loses memory and resets back to the factory default values.
2. Added the ability to set the Powerup Intensity in the IRIS VIT software
3. Added the ability to read the lights Powerup Intensity level in the IRIS VIT software
4. The added functionality to the IRIS VIT is enabled/disabled with a hidden button (easter egg). Click words “Power Up Intensity Level” on the Configuration tab to enable/disable the new controls.
5. Change the default lights in IRIS to SeaStar
6. ROS admitted that their lights were not designed to be multi-dropped on the same comm lines. They have committed to updating the light firmware to accommodate the ability to multidrop. In the meantime, we are relegated to only turning the lights on and off at the predetermined powerup intensity level.

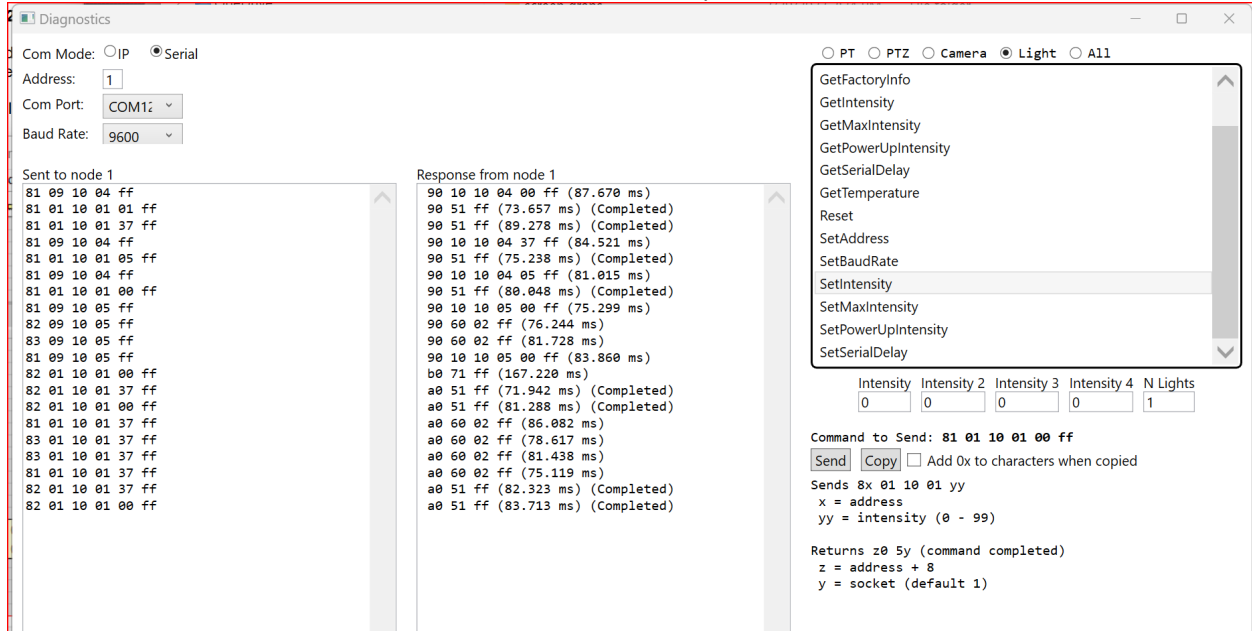
Figure 23. EosCore141 Diagnostics Screen

EosCore141 software diagnostics screen showing communication completed “good” communication and the commands that were sent that don’t indicate completed which is “bad” communication.
