ENGINEERING Exp 379 AMUNDSEN SEA
18 Jan 2019 to 20 March 2019

ENGINEERING

OVERVIEW:

A new Wide Field Of View camera was installed and tested during 4 X VIT deployments made to >4000m.

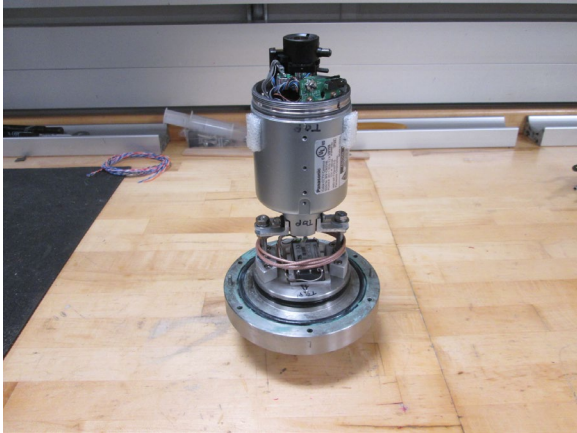
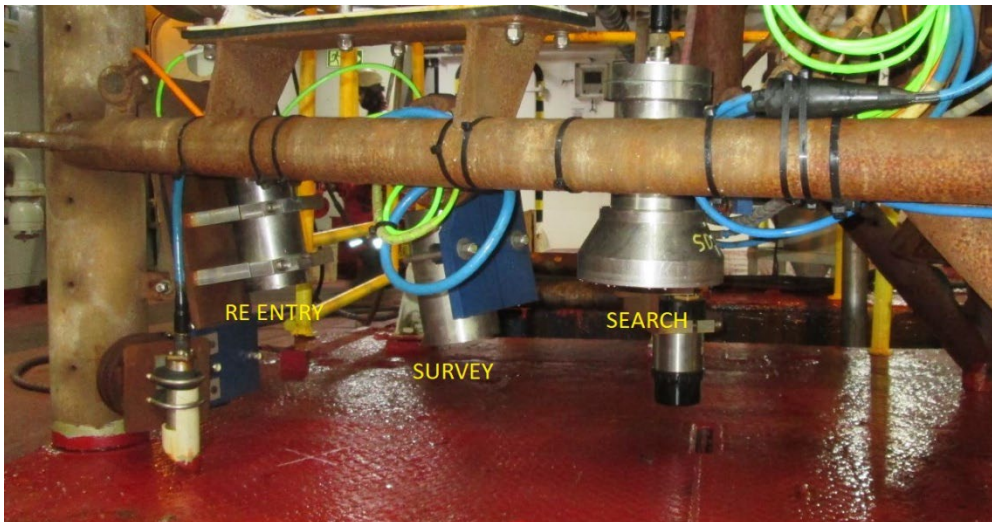
- There was a need for a Wide Field Of View(WFOV) camera to sooner locate the re-entry cone and then to keep it within the camera FOV while maneuvering for re-entry.
- A Panasonic WV-CW314L (PAL) S/N RHV 02181 "Search" camera was installed into one of the older pressure vessels (S/N SD2) and mounted to the frame on a plastic bracket.

- The camera setup was done by manually adjusting the Zoom control to ~ 90 deg FOV angle and then adjusting the focus for this Zoom position. As the LED lighting angle is ~ 90 deg, lighting may not be sufficient for camera angles >90 deg.
- Video from the Search Cam enters the SUBCDVR on Port [In 1C]. It gets data overlaid and exits on Port SDI(4) to Ship TV CH-8. It is also viewable on the SUBCDVR and DP Monitor AV input.

- Operators of the VIT system found the added capability this camera offered, helpful.
- A spare “Search” camera ordered to be installed in the second older pressure vessel.
- Addition of this composite video camera will also improve redundancy as it eliminates the need to change-over the HD-cams from HD-SDI to NTSC format in the case of HD-SDI path failure.

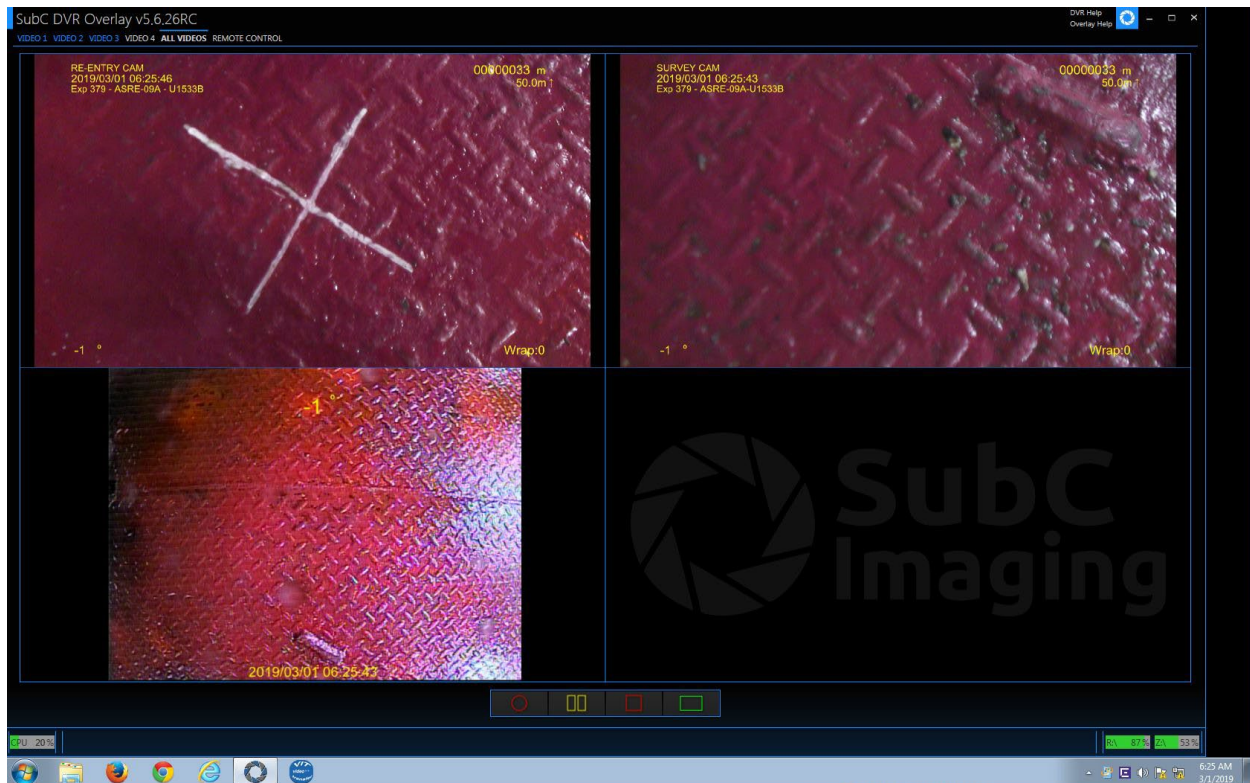
From the screengrab below the wider FOV of Search cam is obvious when compared to the HD Cameras, when observing the cross-pattern on the deck.

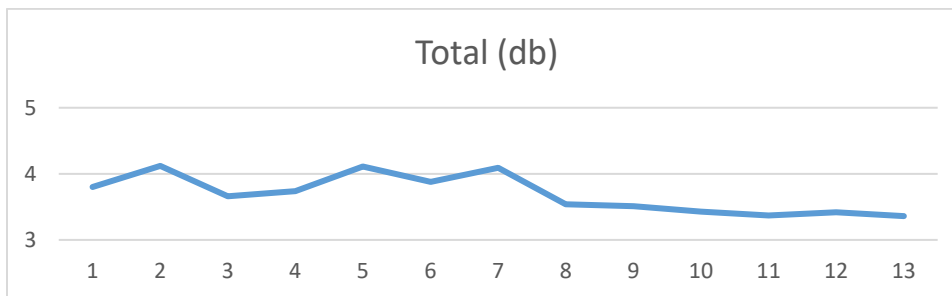
OTDR measurements are periodically made on the spare Brown Fiber from DP to the VIT Frame J-Box. Compared against measurements from previous Expeditions, this could be an early indication of potential issues especially on the FORJ and Umbilical. OTDR measurements on the BRN fiber shows no evidence of optical link degradation.
