The noise during rotation seems to be generated by the friction between the silicon nitride holder and the bearing.

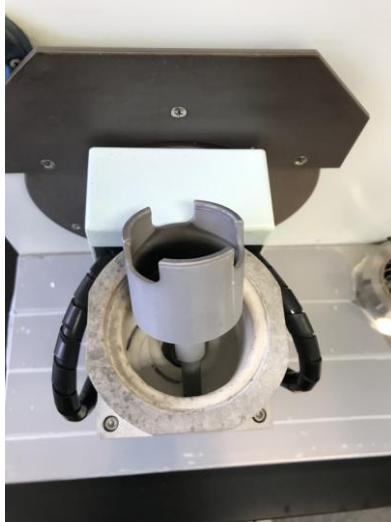
1. Remove the holder of silicon nitride.

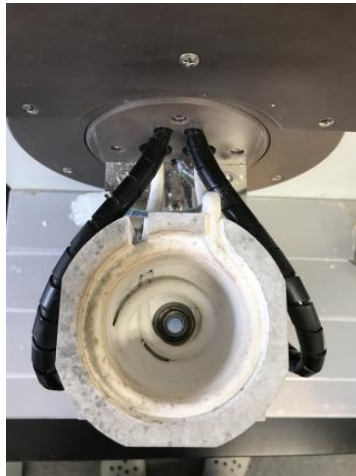
2. Remove the cover attached to the furnace body.
(There are fixing screws on both sides)

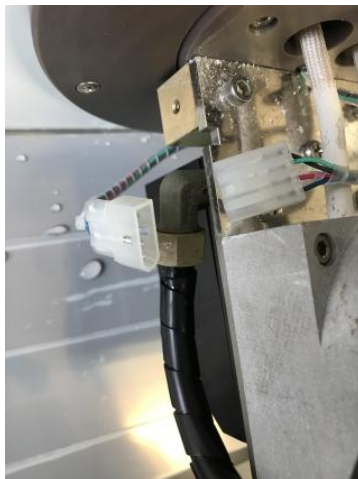
3. Remove the signal connector.

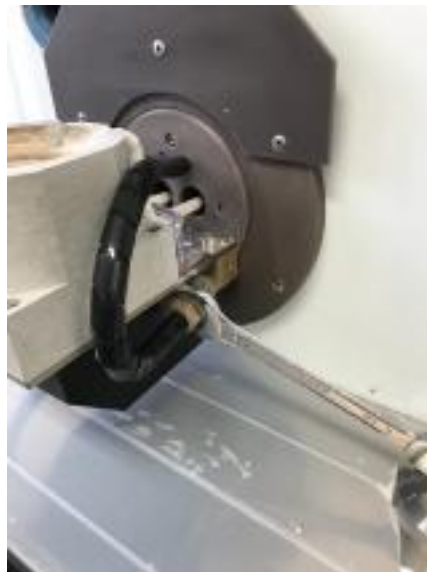
4. Remove the cooling water pipes for in and out by a wrench.
(Please be careful about water leak at this time)

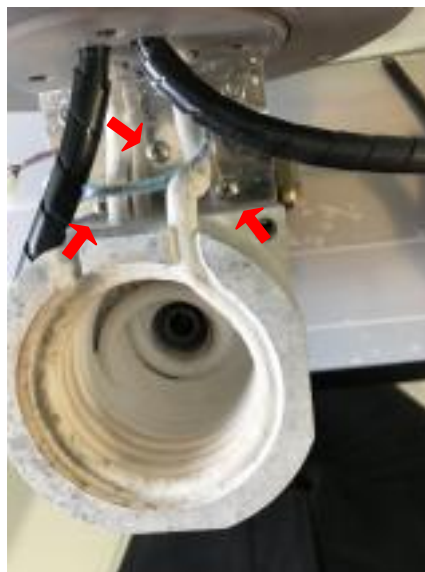
5. Remove the motor box from the furnace body by loosening the three screws.
