Mike Meiring

#### OVERVIEW:

- Changed out old VIT frame with new.
- Modified Antares loggers for high Temp range.
- Deployed Kuster WST.
- Deployed the ETBS Temperature tool.
- Deployed VIT system.
- Researched potential gyros for COT project.

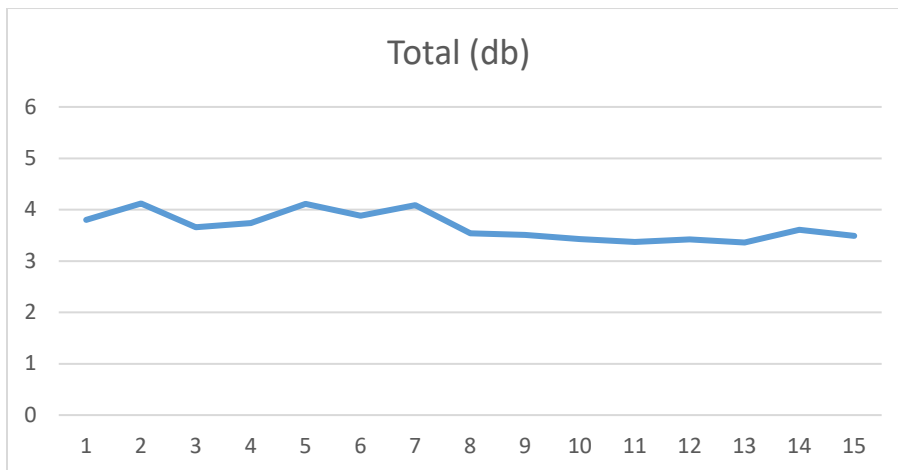
- Flushed devices/connectors with fresh water and sprayed with silicon lubricant.
- Ordered Fusion splices and FO patch cords.
- Optical link integrity:  
OTDR measurements are periodically made on the spare Brown Fiber from DP to the VIT Frame J-Box. Compared against measurements from previous Expeditions, this could be an early indication of potential issues especially on the FORJ and Umbilical. OTDR measurements on the BRN reference fiber shows no evidence of optical link degradation.
