**Expedition 385T**  
**Panama Basin Crustal Architecture and Deep Biosphere**  
**Antofagasta to San Diego**  
**18 August 2019 to 16 September 2019**

**Expedition Engineering Report**  
**J. Van Hyfte, B. Rhinehart, TAMU Engineers**

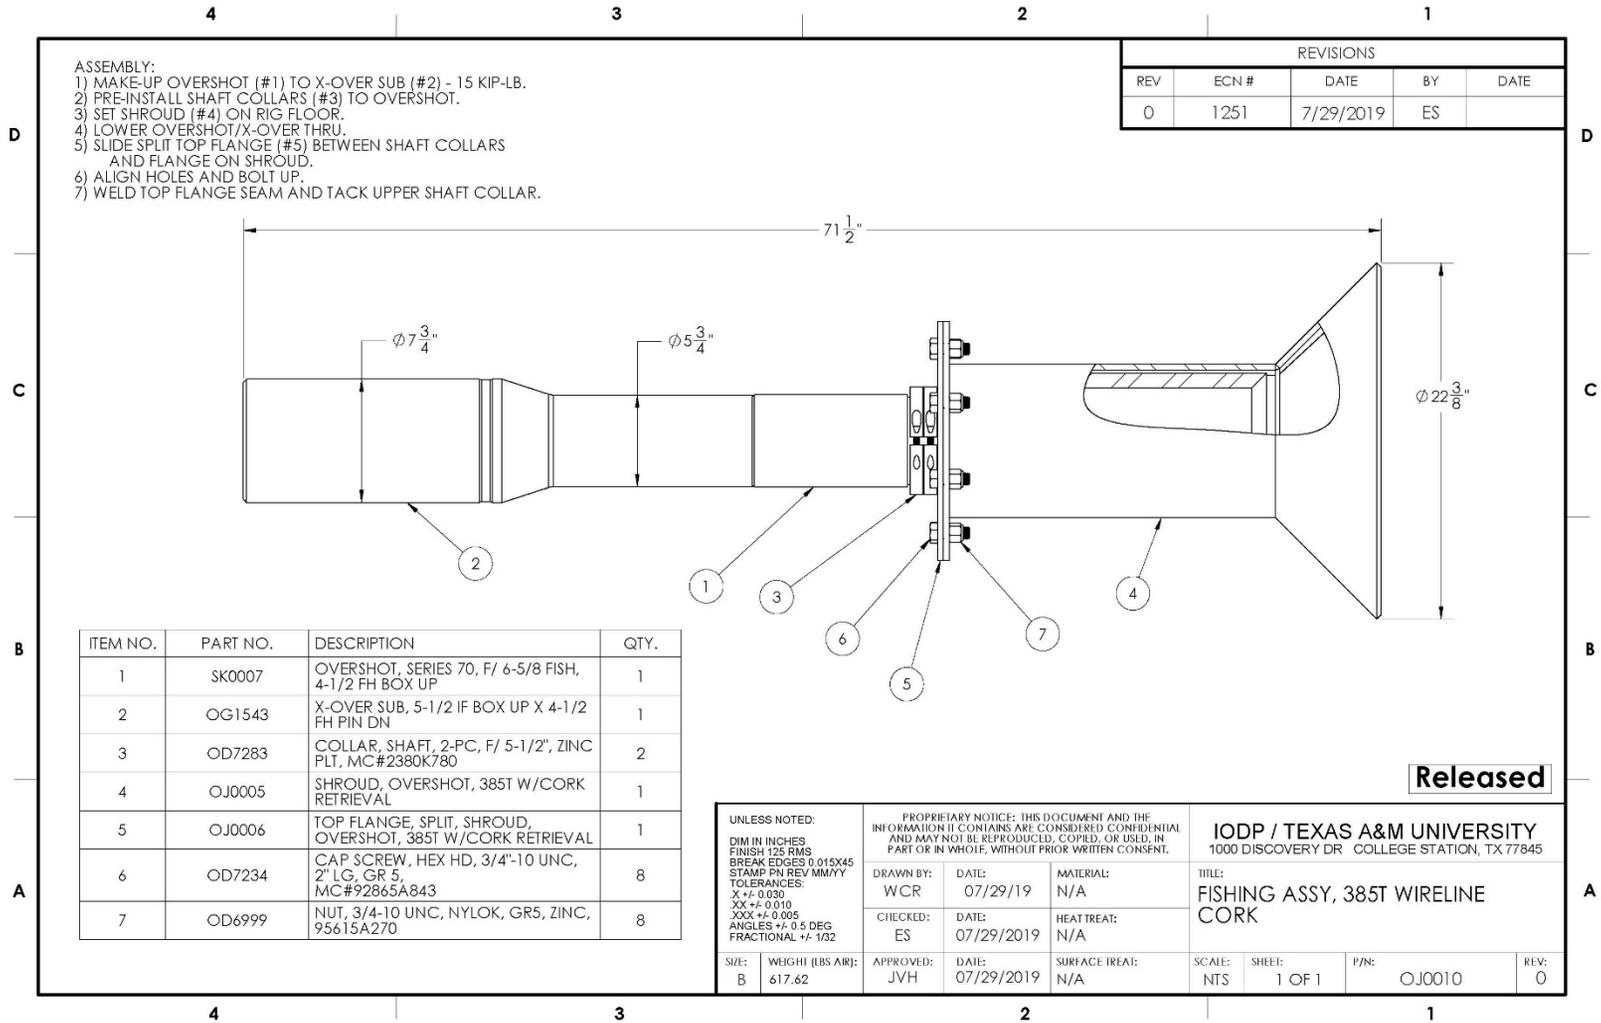
Figure 9 Overshot with Guide Funnel

Fishing in open water is further complicated with no hole to guide the tool down over the fish. A guide funnel was designed to go around the overshot assembly, taking into account that the thin body of the overshot could not be directly welded to (See Figure 9).

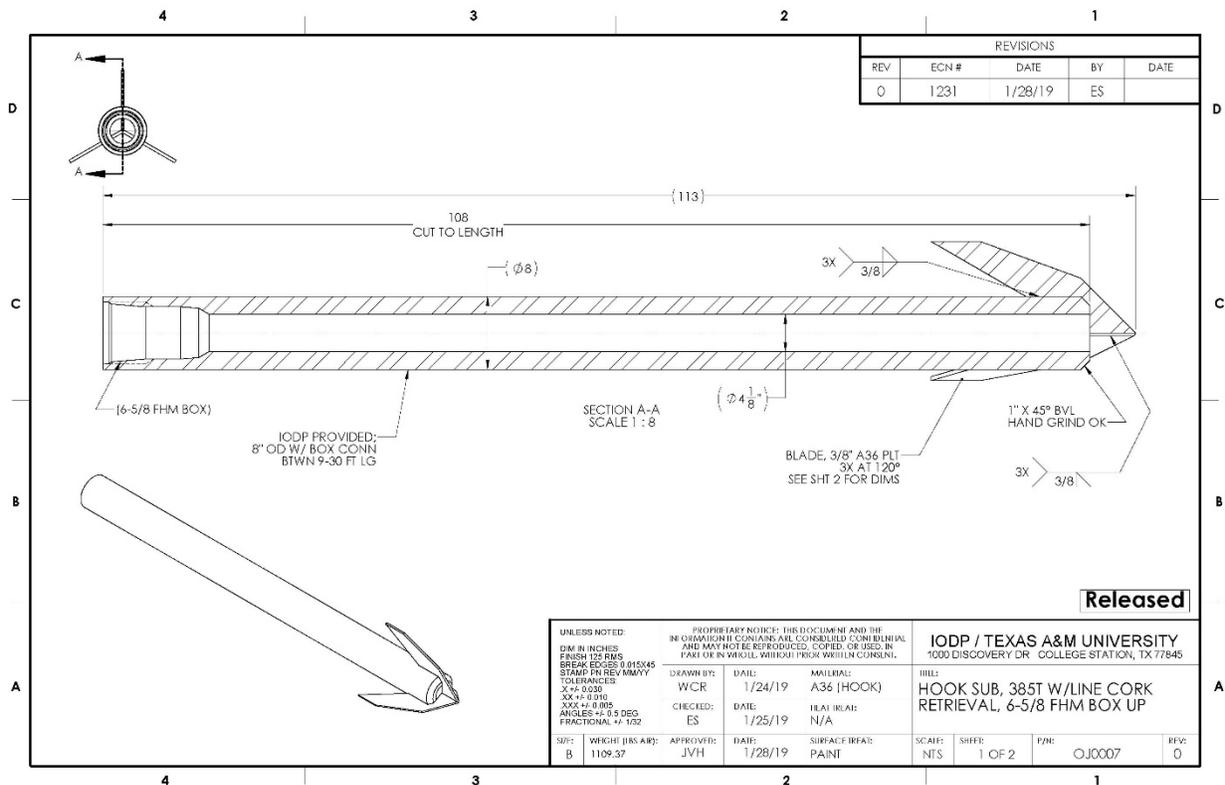
Figure 10 Hook

While a reasonable option for 504B, the overshot assembly was deemed unsuitable for 896A. The 896A installation had been marred by the deployment umbilical breaking, leaving an electronic release (hook) and several meters of umbilical hanging from the top of the center pipe. A "hook" was designed, using the 3D platform model to size it, to attempt to catch the platform by a portion of its superstructure (see Figures 10 and 11). The hook was also made robust so as to be able to "spear" down through the expanded metal of the platform and latch onto the substructure as well. This hook also made a good backup for the overshot option on 504B.

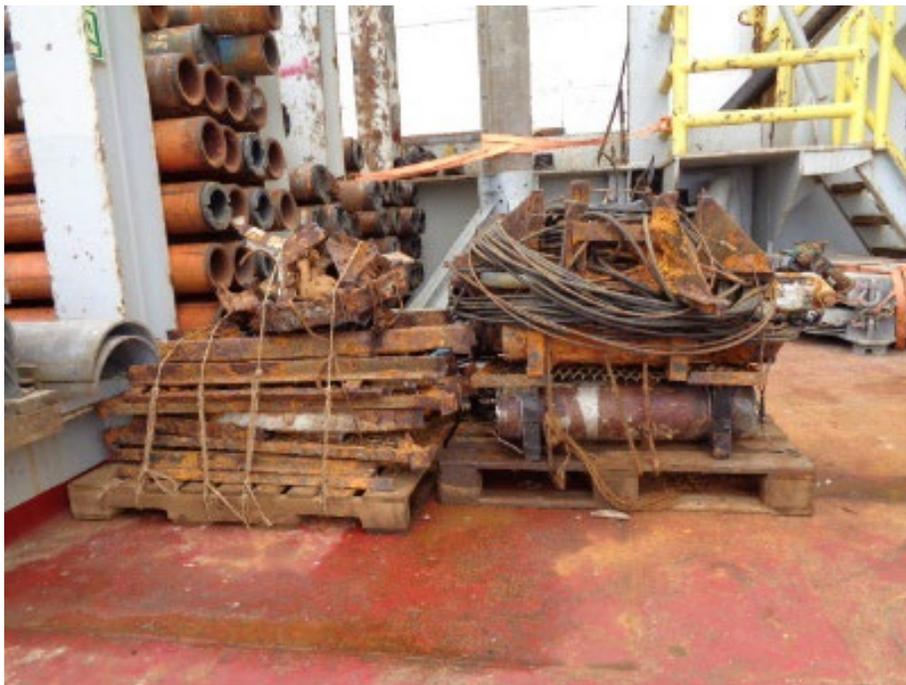
Figure 15 896A Remains

Once in the moon pool (Fig 15), it was confirmed the upper packer and lead-in package were not attached, with the supporting cable parted just a few meters beneath the platform. The platform was flame-cut on one side, allowing it to safely slide off the hook onto the moon pool doors.
