Expedition 390 South Atlantic Transect I

Engineering Report

Cape Town, South Africa to Cape Town, South Africa
09 April 2022 to 09 June 2022

Matthew Allen, Development Engineer

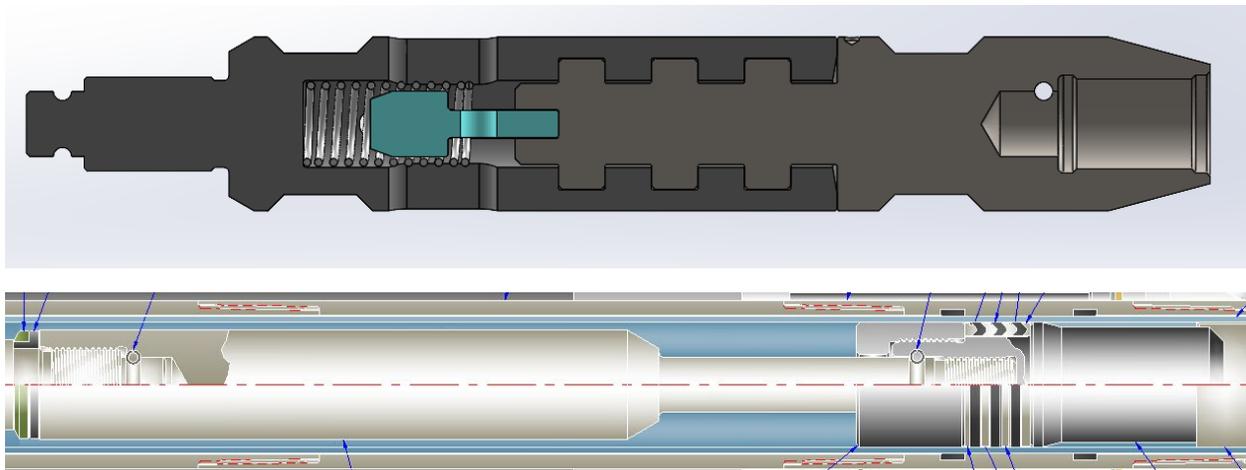
2. Shear value verification testing. 15 pins from on board inventory to shear test to verify values in College Station. This is a check to be sure they are working as intended.
3. Quick connect addition to quickly remove the lower piston and prevent the whole assembly being laid down.

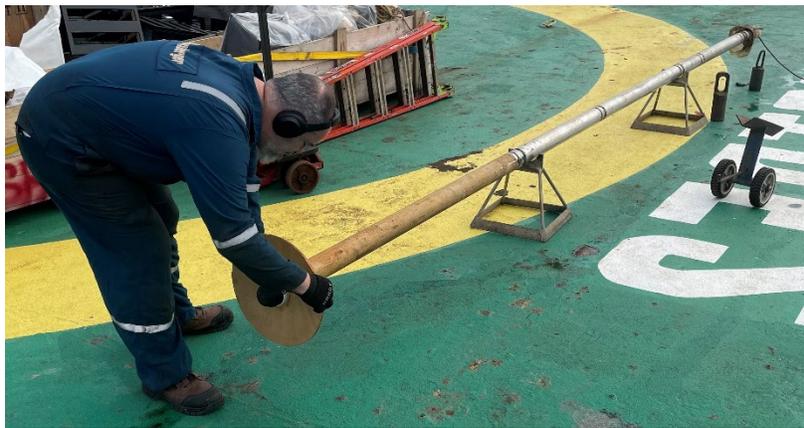
The first test objective was to test DR4 with the known good EC3. DR4 was known to have been used in expeditions before leaving the JR for testing, so we wanted to test it and compare it to the other sonde, DR3. To test the MSS logging tools, the following logging components were made up in order, from top to bottom:

- DTC-H – Telemetry Cartridge
- Adapter Head – Bulkhead
- ELIC – Communications from MSS EC to SLB
- EC – MSS Electronics Cartridge
- DR – MSS Measurement Sonde

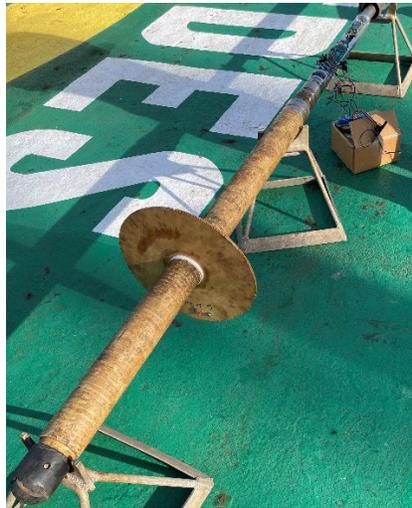
- Startup WAFE and get MSS up and running
- Start recording data
- Wait 1 minute (to establish baseline)
- Put the conductivity coil 20cm from the bottom of the sonde
- Wait 1 minute
- Move the coil 10cm further up from the bottom
- Wait 1 minute
- Repeat previous two steps until the coil is a total of 70cm up from the bottom
- Wait 1 minute
- Remove coil from the sonde (to get a return to baseline) and wait 1 more minute before terminating data recording

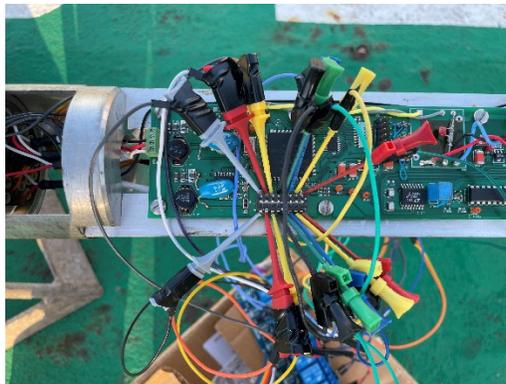
The optimal sensor location on the sondes was found to be from 50 to 60cm as measured from the lower (downhole) end. After confirming the setup was working, EC4 was then tested with DR3 (working sonde). However, after producing noticeable signal response during the first testing, during the second round of testing, EC4 had minimal noticeable signal response.

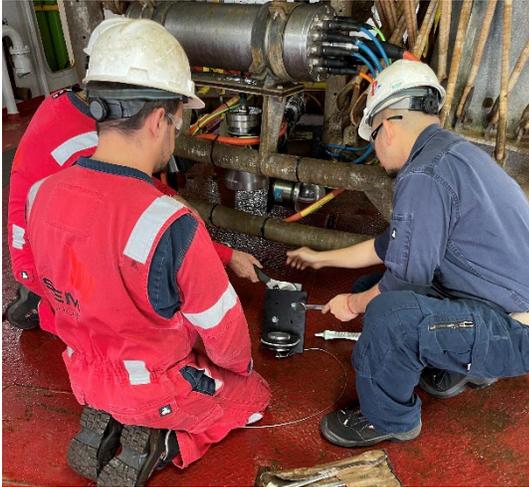
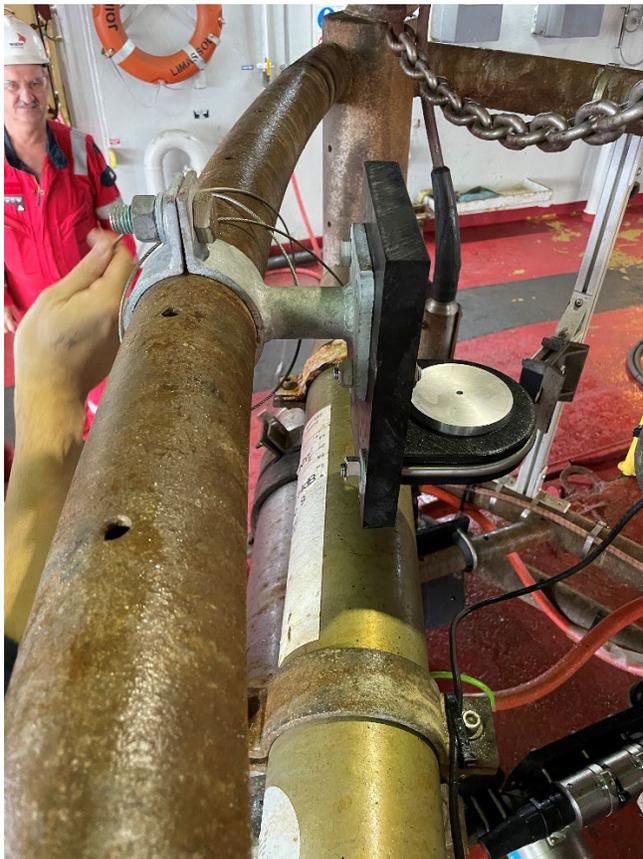
The assembled clamp, with 3D printed light mount and simulated light, was made up to the VIT frame. The VIT was run down to ~5,000m water depth on three different occasions. No visible issues observed. The simulated light was held completely, with no indications of the 3D printed material being affected by hydrostatic pressure under water. The components and light mount were disassembled and shipped back to College Station at the end of the expedition.

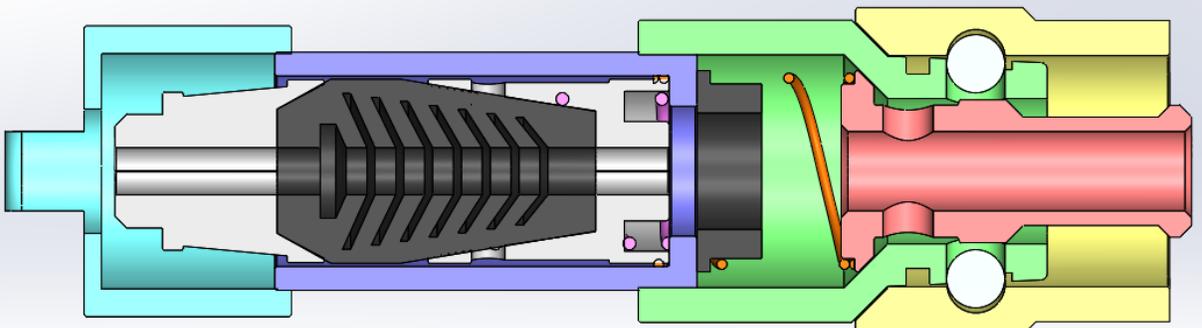
Engaged

Worked with Clay from SLB to reverse engineer the old wireline oil savers. They are in poor condition and are not supported anymore. The components were broken apart with the help of Clay and the rig crew. After measuring each component, a 3D assembly was created in SolidWorks. I was made aware that this may have been a project started in the past.

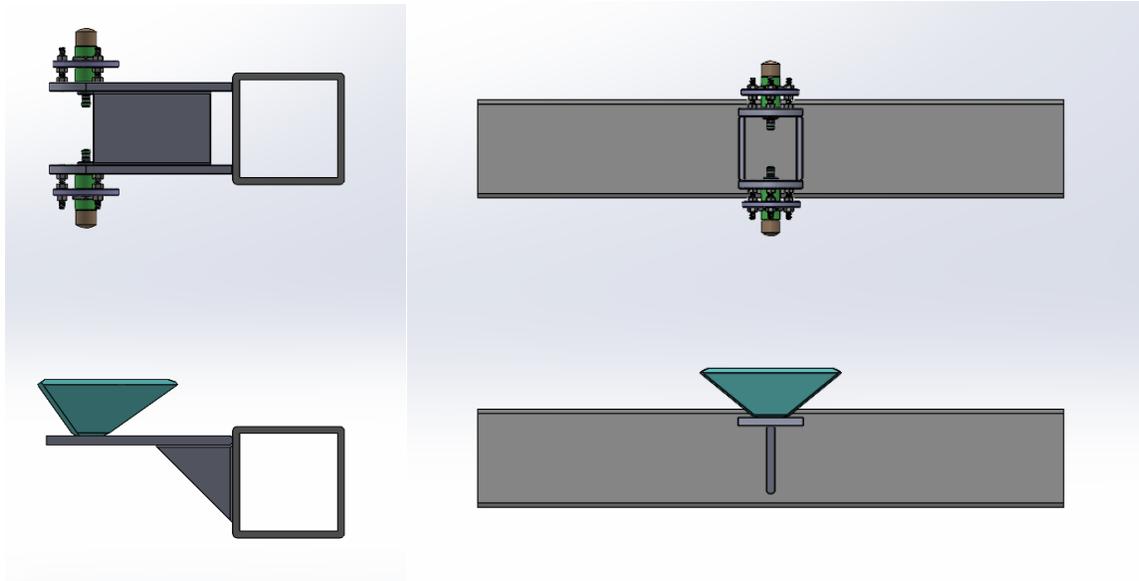
I took what Bill Mills sent and modified the design.

Still a work in progress. Plan is to mount them to the back of the block and compensator trolley.
