Engineering Report Expedition 396T

Dean Ferrell 12/6/21

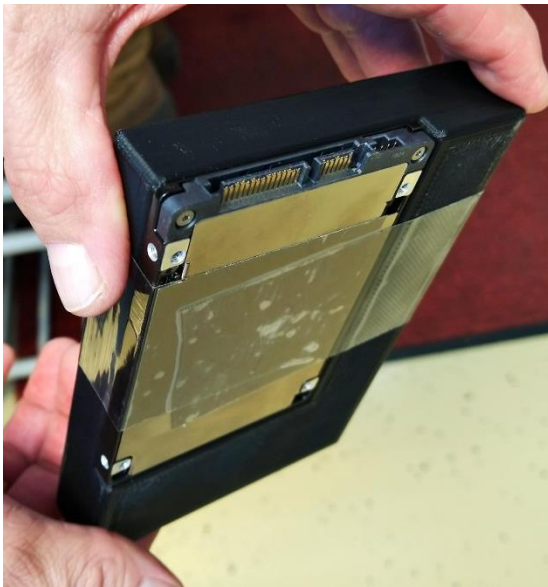
Just prior to COVID, we purchased new solid-state hard drives for the SUBC DVR machines, in hopes that they would provide better video recording without lost frames. Installing these drives were delayed due to COVID until this expedition. Upon opening the drives, we found that they were only 250 GB, too small to act as a recording drive, so installation was postponed until larger drives could be purchased. Near the end of the expedition, we found that there were two sets of drives, one set being 2 TB drives. These drives would not fit in the drive bays due to their small dimensions. Kevin Grigar, designed some carriers that we had 3D printed, to fit in the drive slots. They are now installed, and have been re-labeled as the "R:" drive, so no changes in operational procedure is required.
