Expedition 398P/T

Expedition Engineering Report

J. Van Hyfte, B. Miller, JRSO Engineering Support

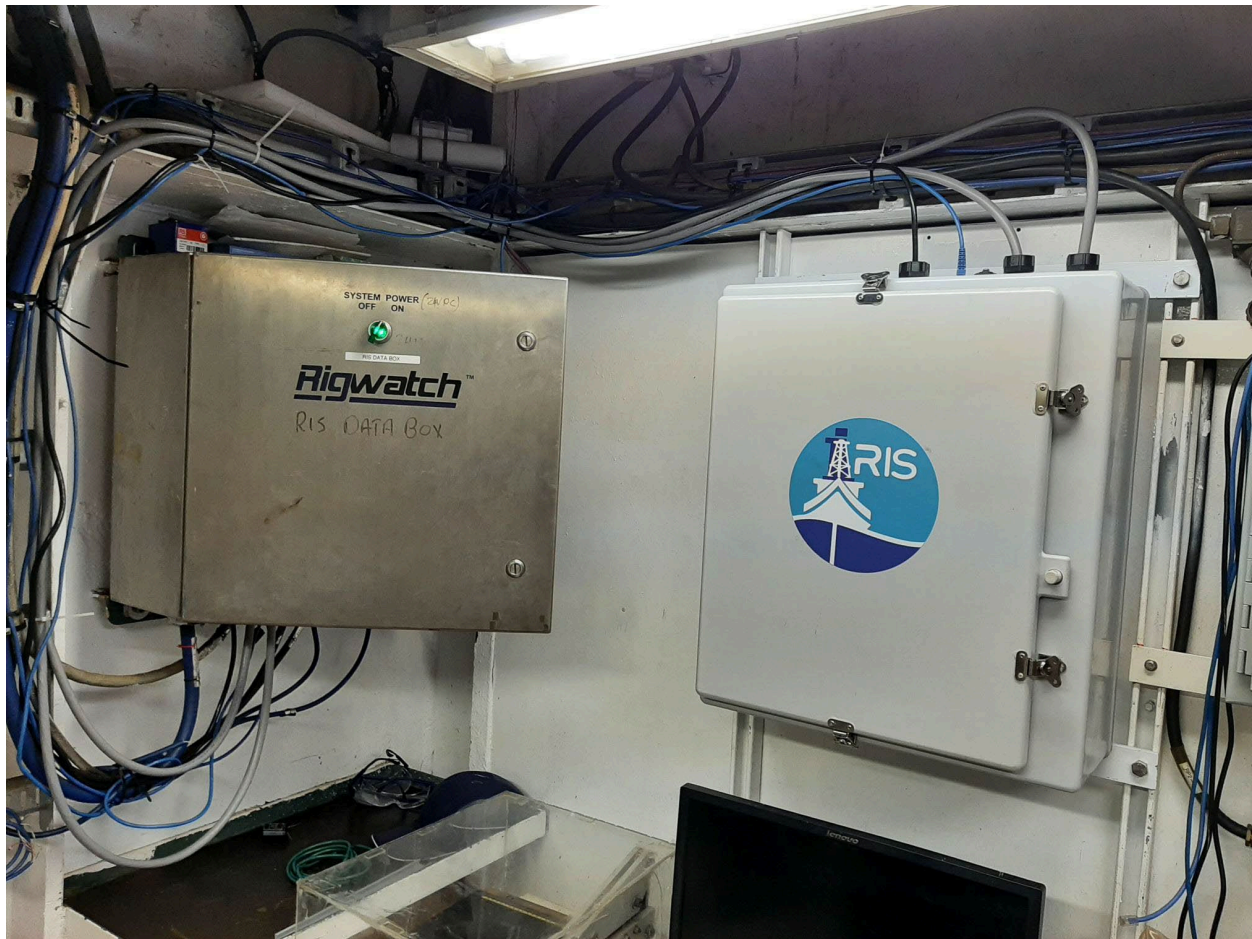
Figure 2. iRIS and RigWatch J-boxes

Figures below show the original layout of each j-box installed in the subsea shack

JRSO contracted a former electronics engineer, Dean Ferrell, to prepare the two (2) existing rig instrumentation system (RIS) junction boxes (j-boxes) in the subsea shack for promoting the iRIS j-box FROM secondary TO primary data collection system and demoting the RigWatch j-box FROM primary TO secondary data collection system. In this move, the j-boxes are now ready when the RigWatch rig instrumentation system is completely removed from service, currently scheduled following JRSO expedition 395 in Fall 2023. At that point, iRIS will be fully implemented, tested, deployed, and integrated into the JRSO's Laboratory Information Management System (LIMS) used to collect all coring, drilling, and lab processing data for all recovered core samples.

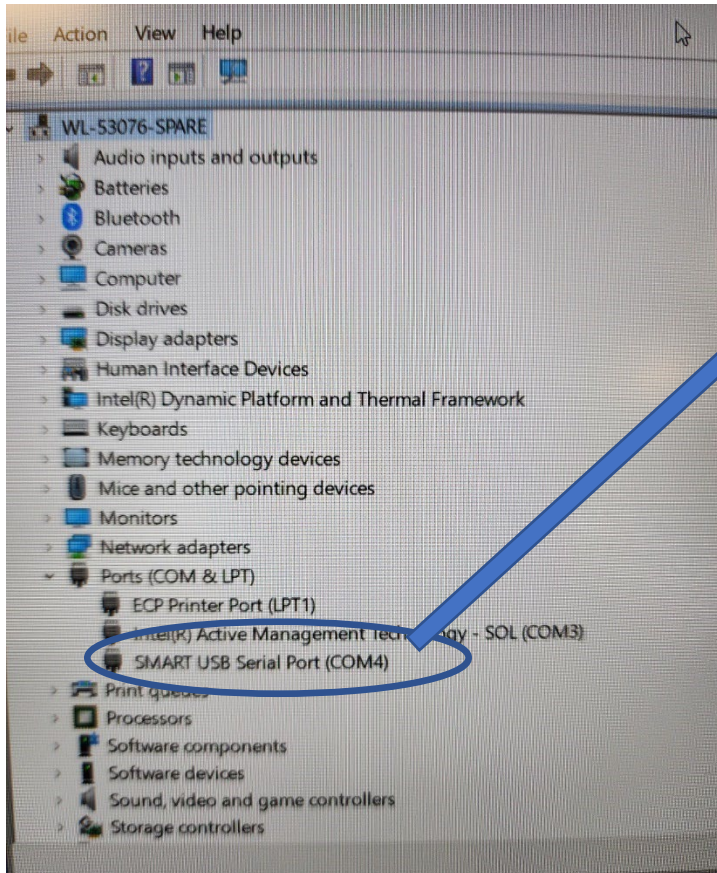
Figure 13. Smart USB → Serial Driver

Working with the JR MCS staff, a fresh laptop was provisioned, and the step-by-step guide supplied by MicroSmart was run. The original driver errors were not observed,

The corrected drivers had to be installed using admin privileges and suppressing the Windows “installation of unsigned drivers” security settings to allow the COM ports to be installed and assigned. With these now installed, communications were restored, and the tool was able to communicate.

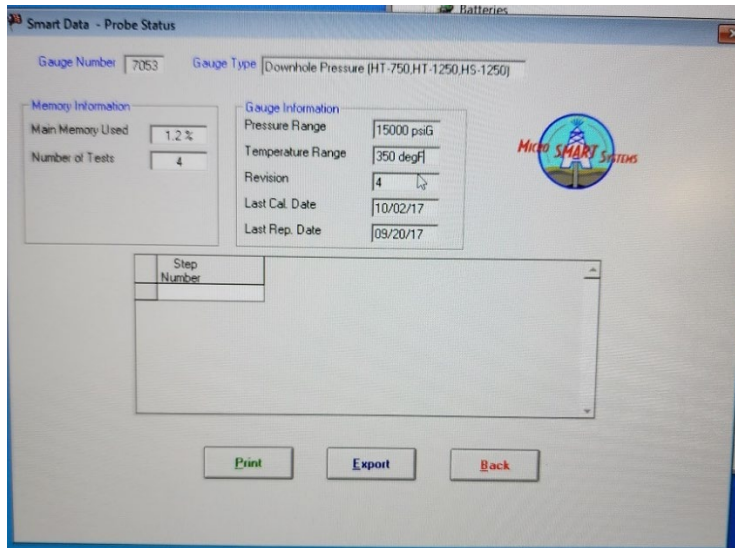
Figure 15. SmartData ready to go

As of this report, all functions are tested and confirmed while using the ETBS datalogger Serial Number 7053. Real time test and reports were generated.

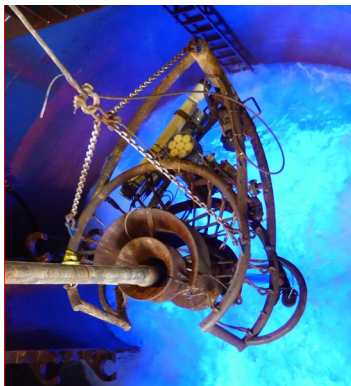
Figure 17. VIT Light Orientation

Left Light – Have intensity control via software, but experience intermittent loss of communication.

Right Light – No intensity control at all.

Center Light - Long control latency (12 second delay from software command to change in light).

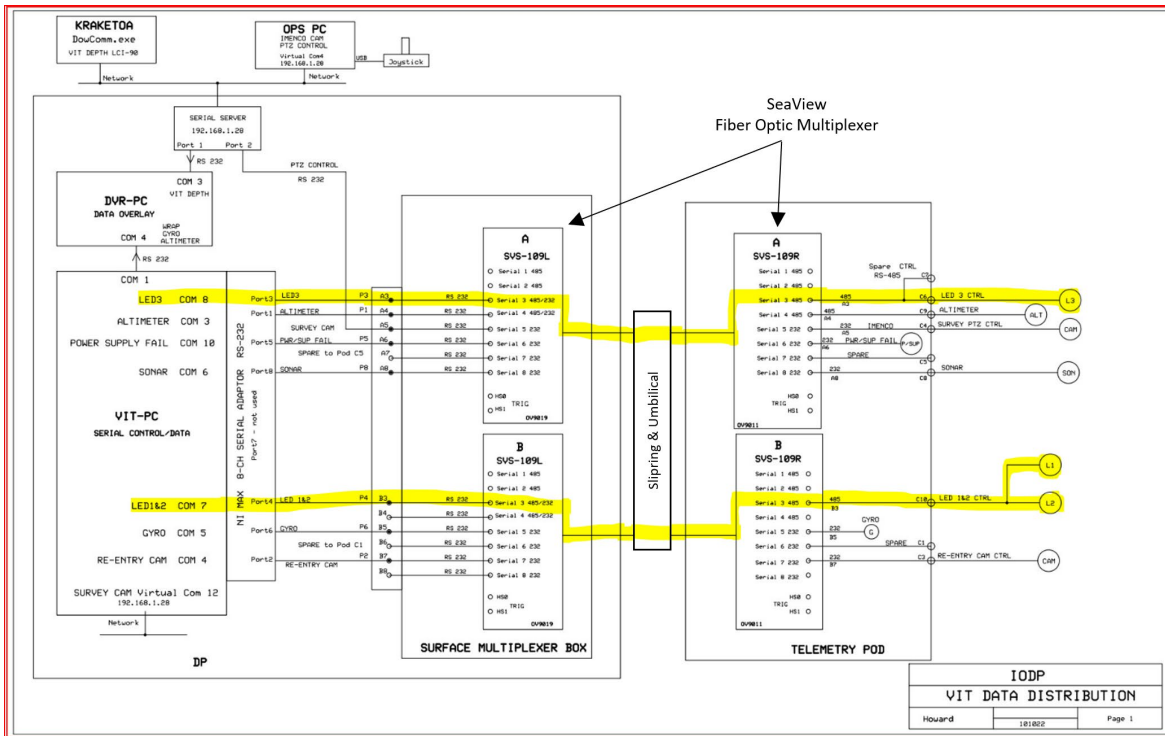
Figure 20. VIT Lighting Communication Path

- There is a communication issue with right and left lights that share the same comm lines. It appears that both lights try to transmit at the same time resulting in framing errors. As a result, only one light can communicate with IRIS and is capable of intensity adjustments.

The lights communicate via 2-wire RS-485 (half duplex) pins 1 & 2 and are powered on pins 5/6 & 7/8.

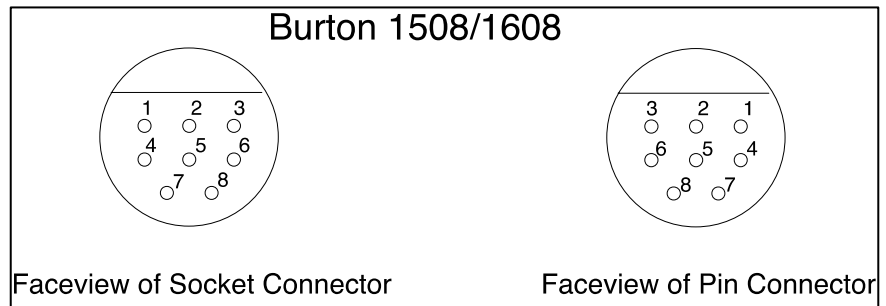
Figure 21. Burton Connector Pinout Diagram

1. RS485 T/R+ (A)
2. RS485 T/R- (B)
3. N/C (X)
4. N/C (X)
5. +24VDC (P)
6. +24VDC RTN (R)
7. +24VDC (P)
8. +24VDC RTN (R)
